# HOME REPORT

BEECHMOUNT, MIDDLE TERRACE, KINGUSSIE, PH21 1EY

# Single Survey

| <b>Date of Inspection</b> | 10 <sup>th</sup> March 2021 |

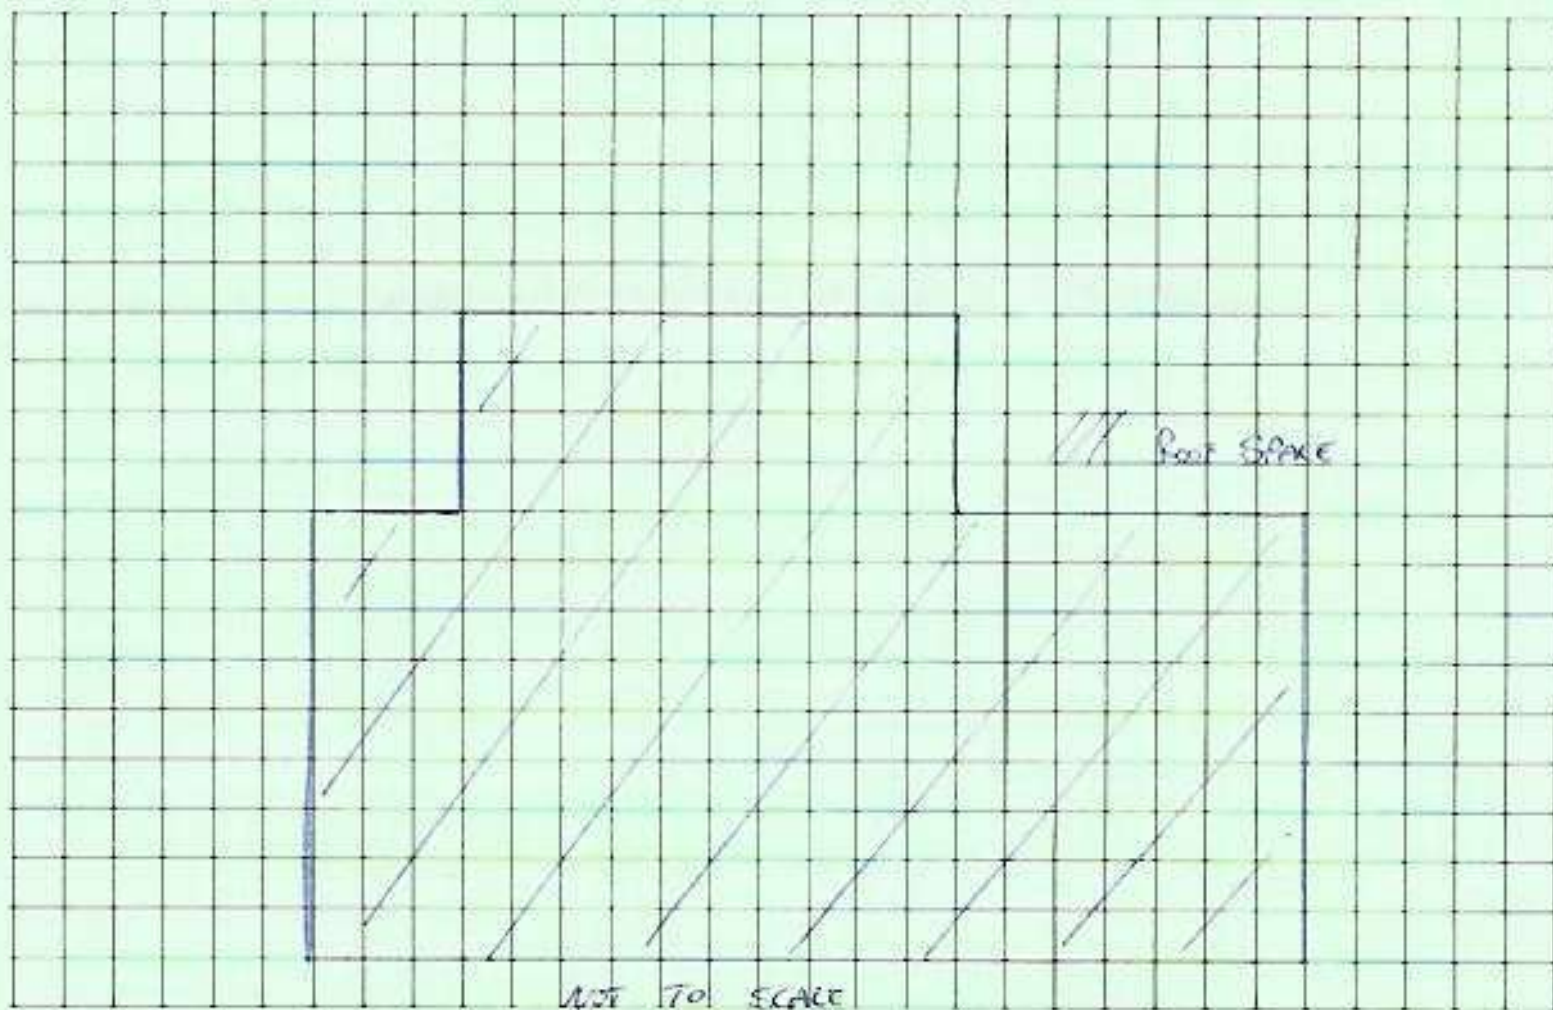
**DRAW PLAN BELOW OF AREAS TREATED, SHOW TYPE OF  
INFESTATION AND GIVE MEASUREMENTS.**

ALL TREATED AREAS SHOWN ABOVE ARE COVERED UNDER THE 30 YEAR PROTECTION PLAN
