# Home Report

Property: **168 glasgow road longcroft  
Glasgow rd  
stirlingshire  
Stirlingshire  
FK4 1QL**

Report reference: **1013077-1-2**

Date of Report: **17/08/2020**

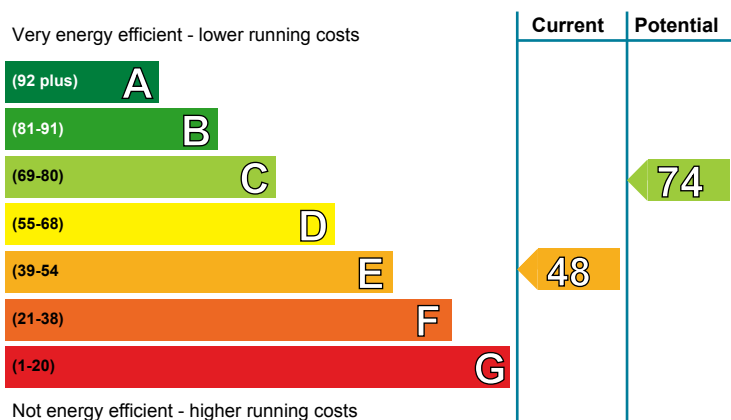
## Energy Efficiency Rating

This graph shows the current efficiency of your home, taking into account both energy efficiency and fuel costs. The higher this rating, the lower your fuel bills are likely to be.

Your current rating is **band E (48)**. The average rating for EPCs in Scotland is **band D (61)**.

The potential rating shows the effect of undertaking all of the improvement measures listed within your recommendations report.

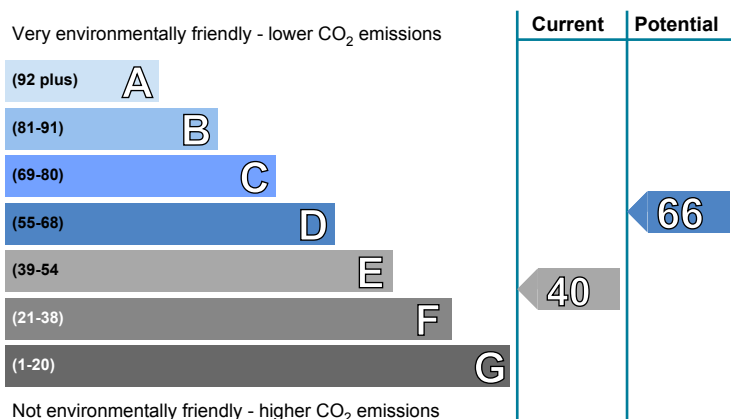
## Environmental Impact (CO<sub>2</sub>) Rating

This graph shows the effect of your home on the environment in terms of carbon dioxide (CO<sub>2</sub>) emissions. The higher the rating, the less impact it has on the environment.

The potential rating shows the effect of undertaking all of the improvement measures listed within your recommendations report.
