# Home Report

Property: **Traquair/Elchies  
Craigellachie  
Aberlour  
Moray  
AB38 9SP**

Date of Report: **28/09/2020**

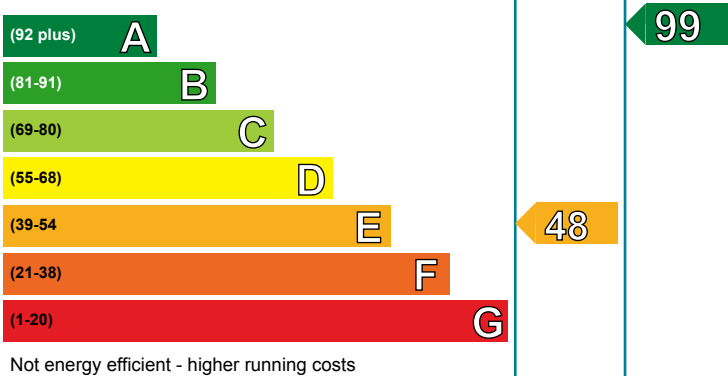
## Energy Efficiency Rating

This graph shows the current efficiency of your home, taking into account both energy efficiency and fuel costs. The higher this rating, the lower your fuel bills are likely to be.

Your current rating is **band E (48)**. The average rating for EPCs in Scotland is **band D (61)**.

The potential rating shows the effect of undertaking all of the improvement measures listed within your recommendations report.

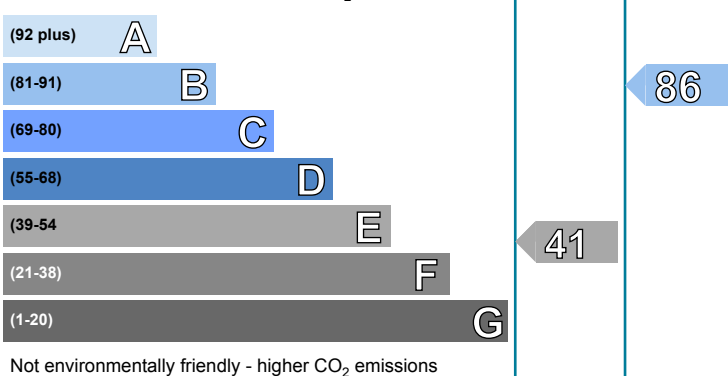
## Environmental Impact (CO<sub>2</sub>) Rating

This graph shows the effect of your home on the environment in terms of carbon dioxide (CO<sub>2</sub>) emissions. The higher the rating, the less impact it has on the environment.

The potential rating shows the effect of undertaking all of the improvement measures listed within your recommendations report.
