# HOME REPORT

7 MID LANE  
BRACO  
DUNBLANE  
FK15 9QR

# Energy Performance Certificate (EPC)

7 MID LANE, BRACO, DUNBLANE, FK15 9QR

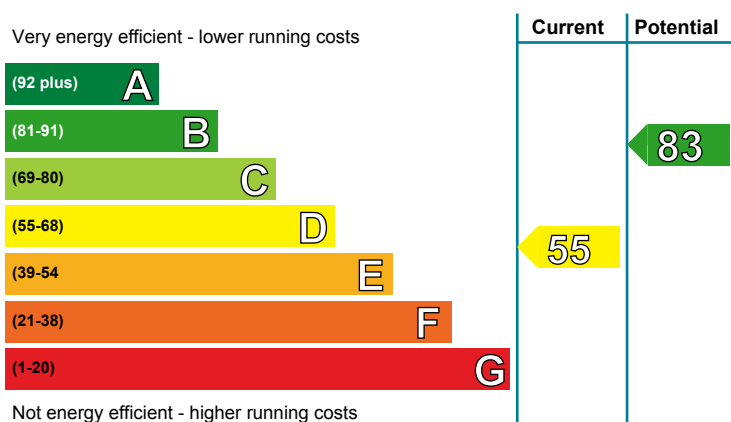
## Energy Efficiency Rating

This graph shows the current efficiency of your home, taking into account both energy efficiency and fuel costs. The higher this rating, the lower your fuel bills are likely to be.

Your current rating is **band D (55)**. The average rating for EPCs in Scotland is **band D (61)**.

The potential rating shows the effect of undertaking all of the improvement measures listed within your recommendations report.

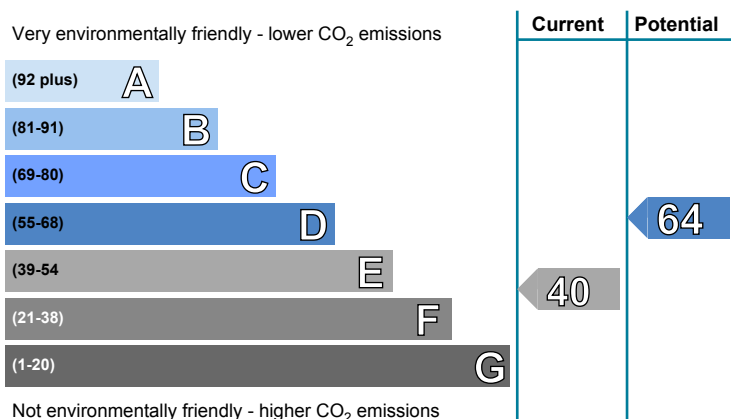
## Environmental Impact (CO<sub>2</sub>) Rating

This graph shows the effect of your home on the environment in terms of carbon dioxide (CO<sub>2</sub>) emissions. The higher the rating, the less impact it has on the environment.

Your current rating is **band E (40)**. The average rating for EPCs in Scotland is **band D (59)**.

The potential rating shows the effect of undertaking all of the improvement measures listed within your recommendations report.
