# Home Report

Property: **2/2  
3 Dixon Road  
Glasgow  
Lanarkshire  
G42 8AS**

Prepared by: **Alan Bain MRICS**

Date of Report: **17/09/2020**

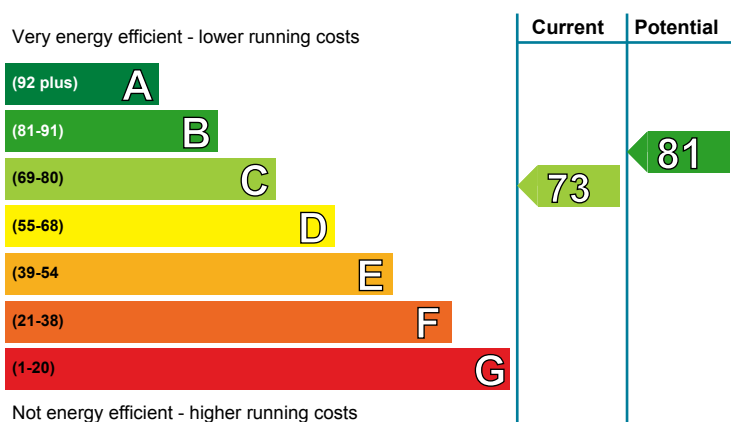
## Energy Efficiency Rating

This graph shows the current efficiency of your home, taking into account both energy efficiency and fuel costs. The higher this rating, the lower your fuel bills are likely to be.

Your current rating is **band C (73)**. The average rating for EPCs in Scotland is **band D (61)**.

The potential rating shows the effect of undertaking all of the improvement measures listed within your recommendations report.

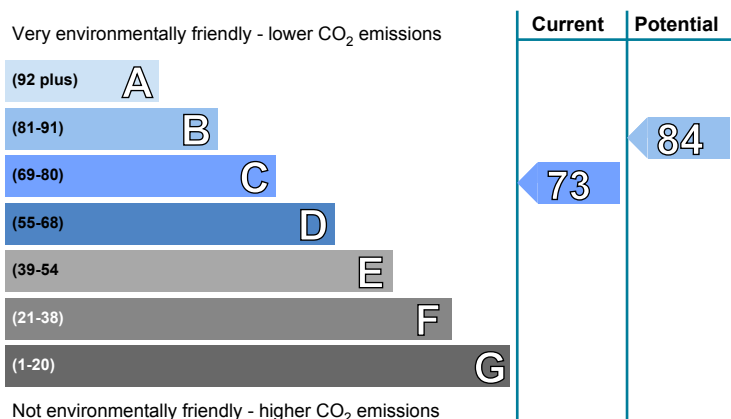
## Environmental Impact (CO<sub>2</sub>) Rating

This graph shows the effect of your home on the environment in terms of carbon dioxide (CO<sub>2</sub>) emissions. The higher the rating, the less impact it has on the environment.

The potential rating shows the effect of undertaking all of the improvement measures listed within your recommendations report.
