# Single Survey

22 Northern Road  
Kintore  
Inverurie  
AB51 0YL

| <b>Date of inspection</b> | 11th February 2020 |

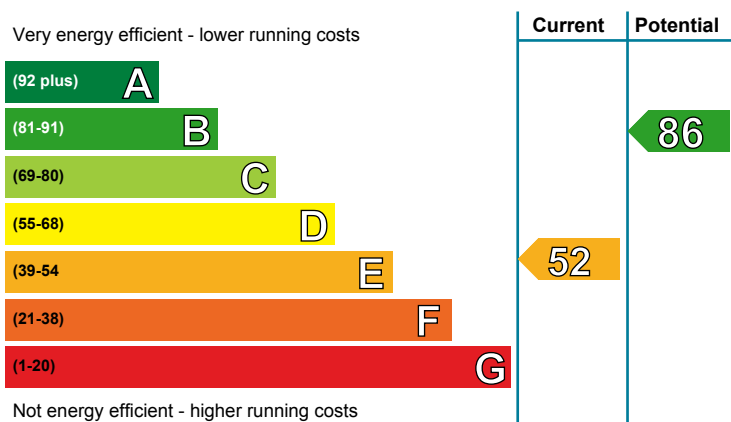
## Energy Efficiency Rating

This graph shows the current efficiency of your home, taking into account both energy efficiency and fuel costs. The higher this rating, the lower your fuel bills are likely to be.

Your current rating is **band E (52)**. The average rating for EPCs in Scotland is **band D (61)**.

The potential rating shows the effect of undertaking all of the improvement measures listed within your recommendations report.

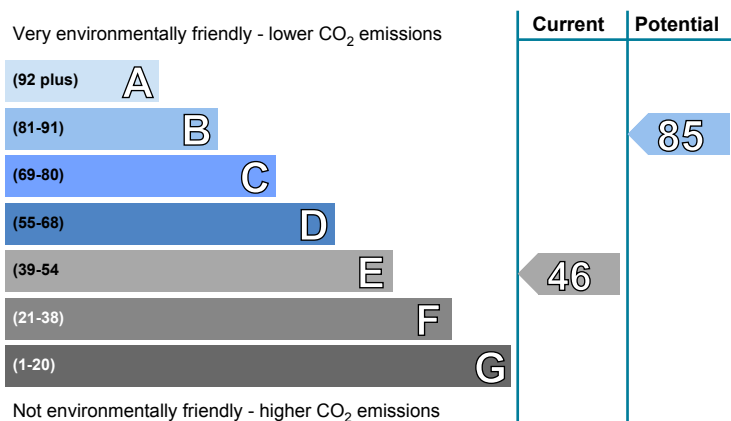
## Environmental Impact (CO<sub>2</sub>) Rating

This graph shows the effect of your home on the environment in terms of carbon dioxide (CO<sub>2</sub>) emissions. The higher the rating, the less impact it has on the environment.
