# Home Report

Property: **Lawrence Cottage  
Old Rayne  
Insch  
Aberdeenshire  
AB52 6RY**

Report reference: **1047697-1-2**

Date of Report: **29/09/2020**

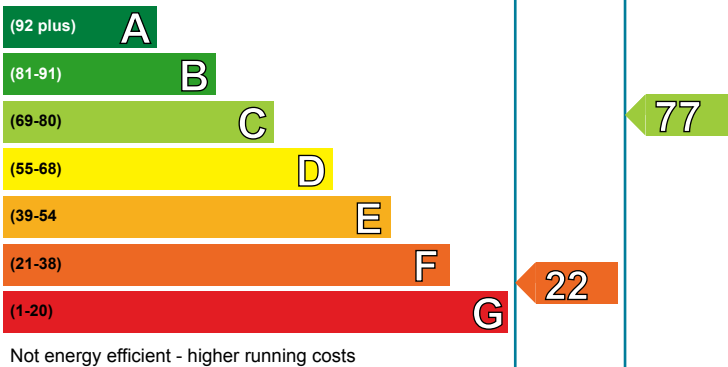
## Energy Efficiency Rating

This graph shows the current efficiency of your home, taking into account both energy efficiency and fuel costs. The higher this rating, the lower your fuel bills are likely to be.

Your current rating is **band F (22)**. The average rating for EPCs in Scotland is **band D (61)**.

The potential rating shows the effect of undertaking all of the improvement measures listed within your recommendations report.

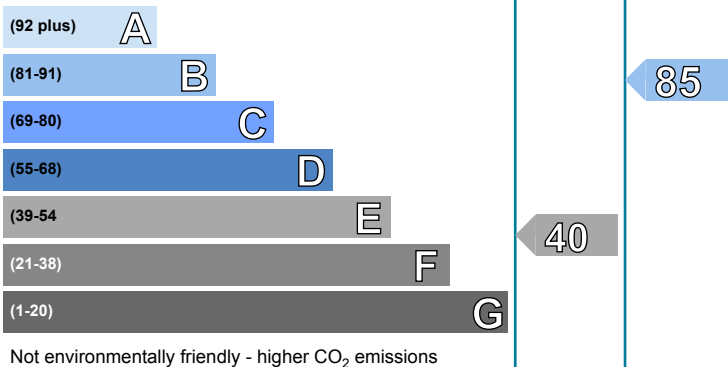
## Environmental Impact (CO<sub>2</sub>) Rating

This graph shows the effect of your home on the environment in terms of carbon dioxide (CO<sub>2</sub>) emissions. The higher the rating, the less impact it has on the environment.

The potential rating shows the effect of undertaking all of the improvement measures listed within your recommendations report.
