# Home Report

HILLVIEW DESKFORD

BUCKIE  
AB56 5YB

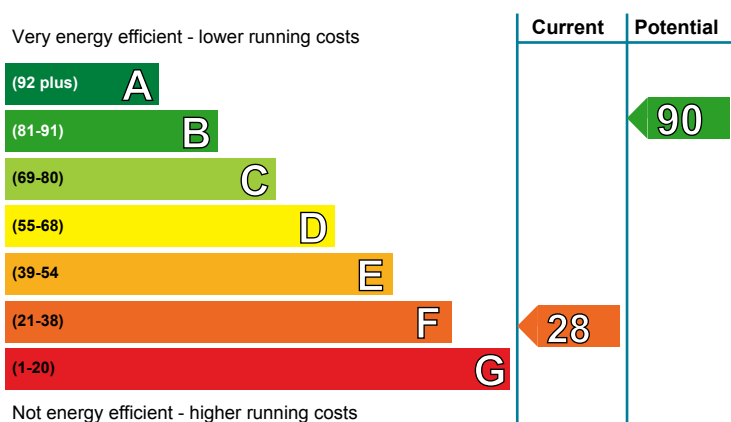
## Energy Efficiency Rating

This graph shows the current efficiency of your home, taking into account both energy efficiency and fuel costs. The higher this rating, the lower your fuel bills are likely to be.

Your current rating is **band F (28)**. The average rating for EPCs in Scotland is **band D (61)**.

The potential rating shows the effect of undertaking all of the improvement measures listed within your recommendations report.

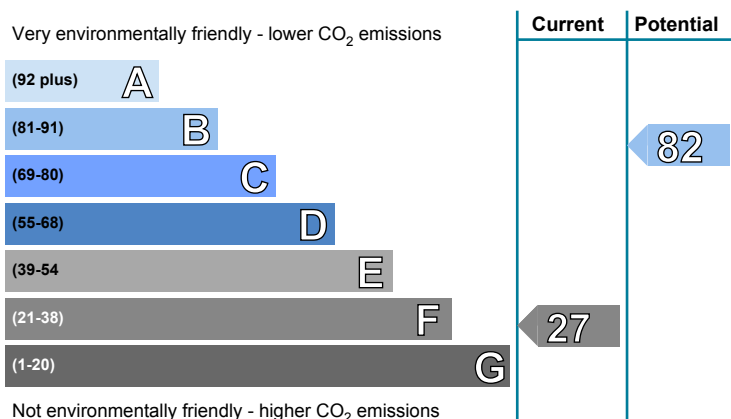
## Environmental Impact (CO<sub>2</sub>) Rating

This graph shows the effect of your home on the environment in terms of carbon dioxide (CO<sub>2</sub>) emissions. The higher the rating, the less impact it has on the environment.

The potential rating shows the effect of undertaking all of the improvement measures listed within your recommendations report.
