# Home Report

14 Hilltop Drive  
WESTHILL  
AB32 6PL

# Single Survey

| Property address | 14 HILLTOP DRIVE<br>WESTHILL<br>AB32 6PL |

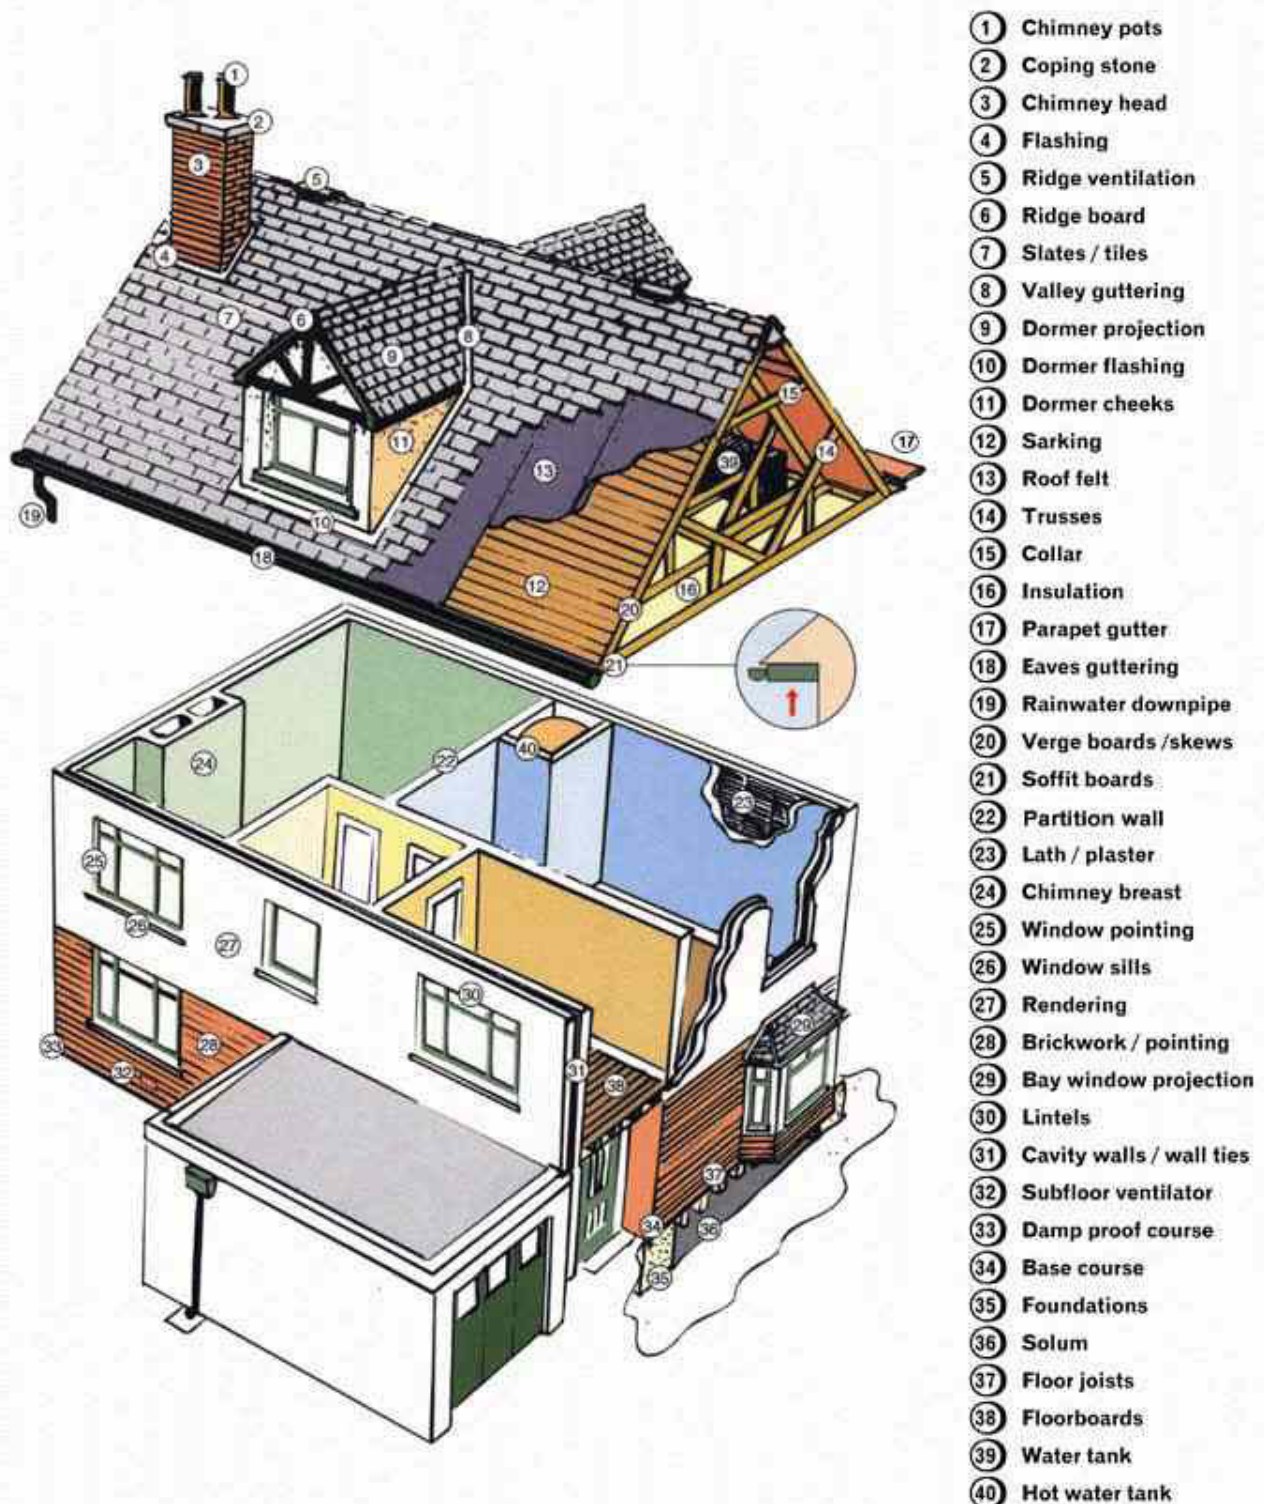
## Sectional Diagram showing elements of a typical house

Reference may be made in this report to some or all of the above component parts of the property. This diagram may assist you in locating and understanding these items.
