Home Report

Property: **24e
Moncur Crescent
Dundee
Angus
DD3 8AA**

Energy Performance Certificate (EPC)

Schedule 1

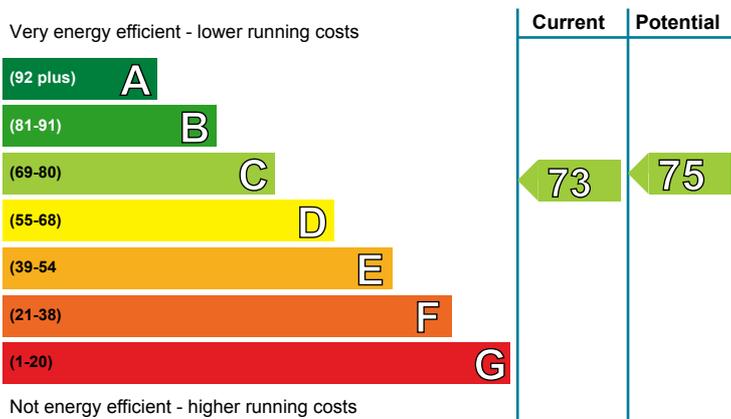
Energy Efficiency Rating

This graph shows the current efficiency of your home, taking into account both energy efficiency and fuel costs. The higher this rating, the lower your fuel bills are likely to be.

Your current rating is **band C (73)**. The average rating for EPCs in Scotland is **band D (61)**.

The potential rating shows the effect of undertaking all of the improvement measures listed within your recommendations report.

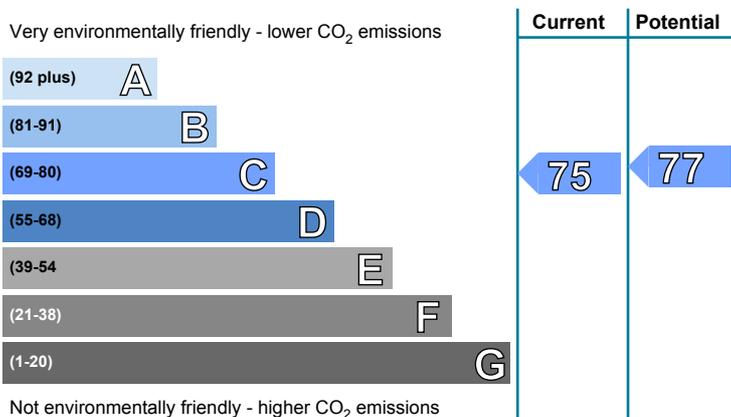
Environmental Impact (CO₂) Rating

This graph shows the effect of your home on the environment in terms of carbon dioxide (CO₂) emissions. The higher the rating, the less impact it has on the environment.

The potential rating shows the effect of undertaking all of the improvement measures listed within your recommendations report.
