ARDGLASSIE CROFT RATHEN

# Home Report

ARDGLASSIE CROFT, RATHEN, FRASERBURGH, AB43 8UP

# Scottish Single Survey

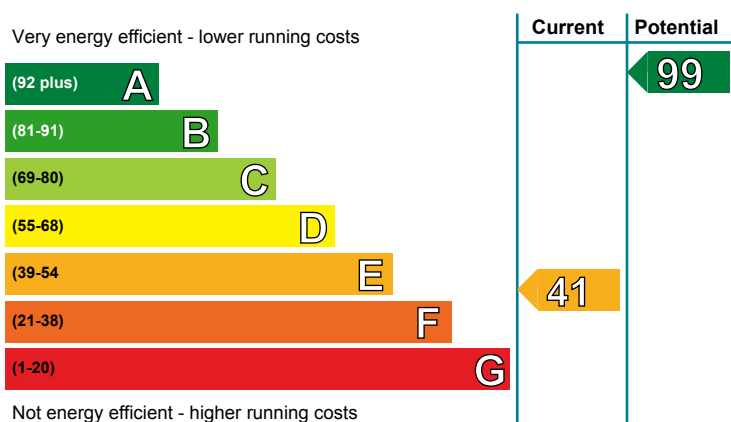
## Energy Efficiency Rating

This graph shows the current efficiency of your home, taking into account both energy efficiency and fuel costs. The higher this rating, the lower your fuel bills are likely to be.

Your current rating is **band E (41)**. The average rating for EPCs in Scotland is **band D (61)**.

The potential rating shows the effect of undertaking all of the improvement measures listed within your recommendations report.

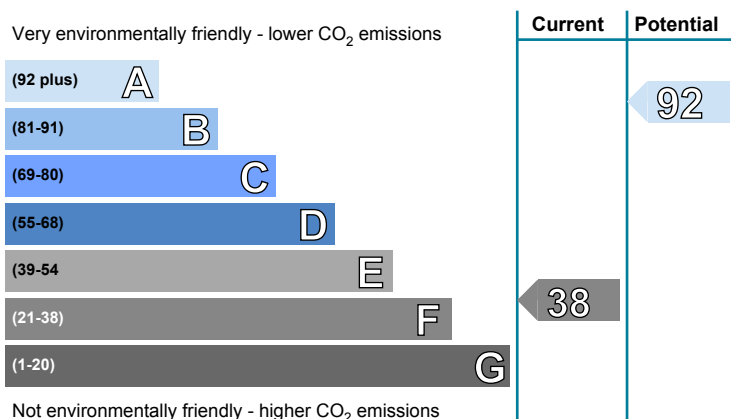
## Environmental Impact (CO<sub>2</sub>) Rating

This graph shows the effect of your home on the environment in terms of carbon dioxide (CO<sub>2</sub>) emissions. The higher the rating, the less impact it has on the environment.

The potential rating shows the effect of undertaking all of the improvement measures listed within your recommendations report.
