# Home Report

Flat 1/1, 75 Watson Street  
Dundee  
DD4 6HG

# single survey

## survey report on:

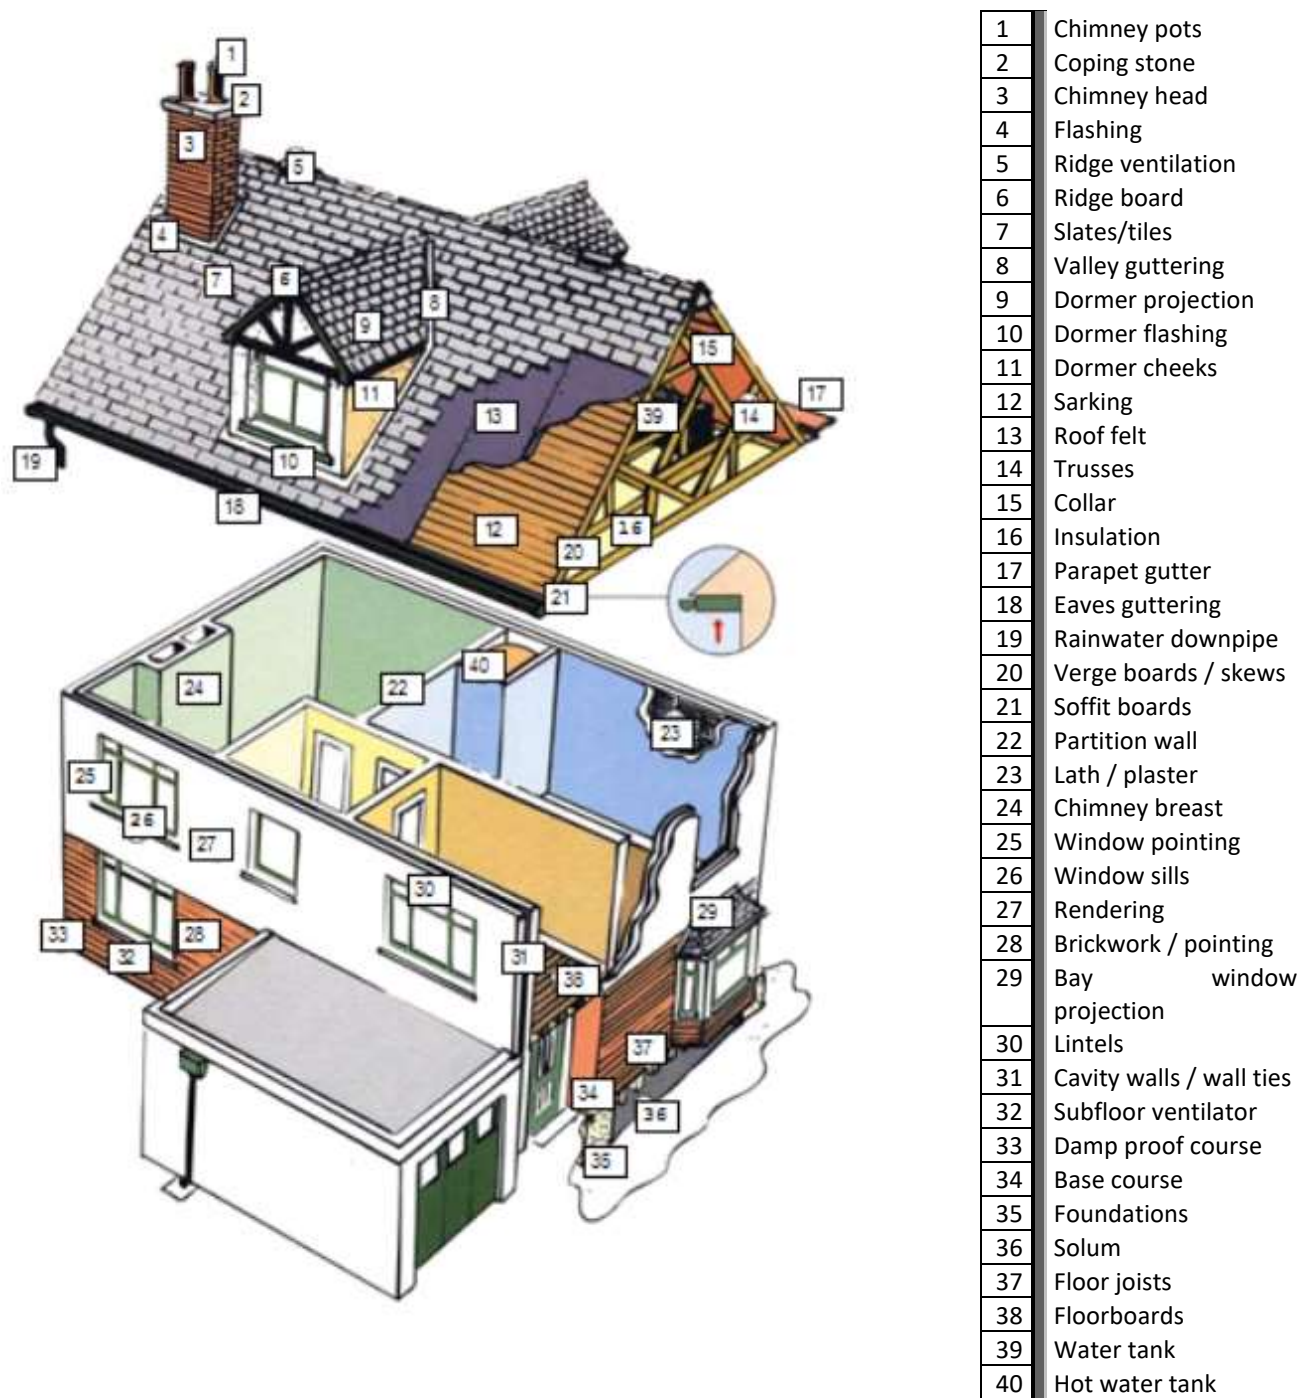
# Sectional Diagram showing elements of a typical house

Reference may be made in this report to some or all of the above component parts of the property. This diagram may assist you in locating and understanding these items.
