# Home Report

107 High Street  
Nairn  
IV12 4DB

# single survey

## survey report on:

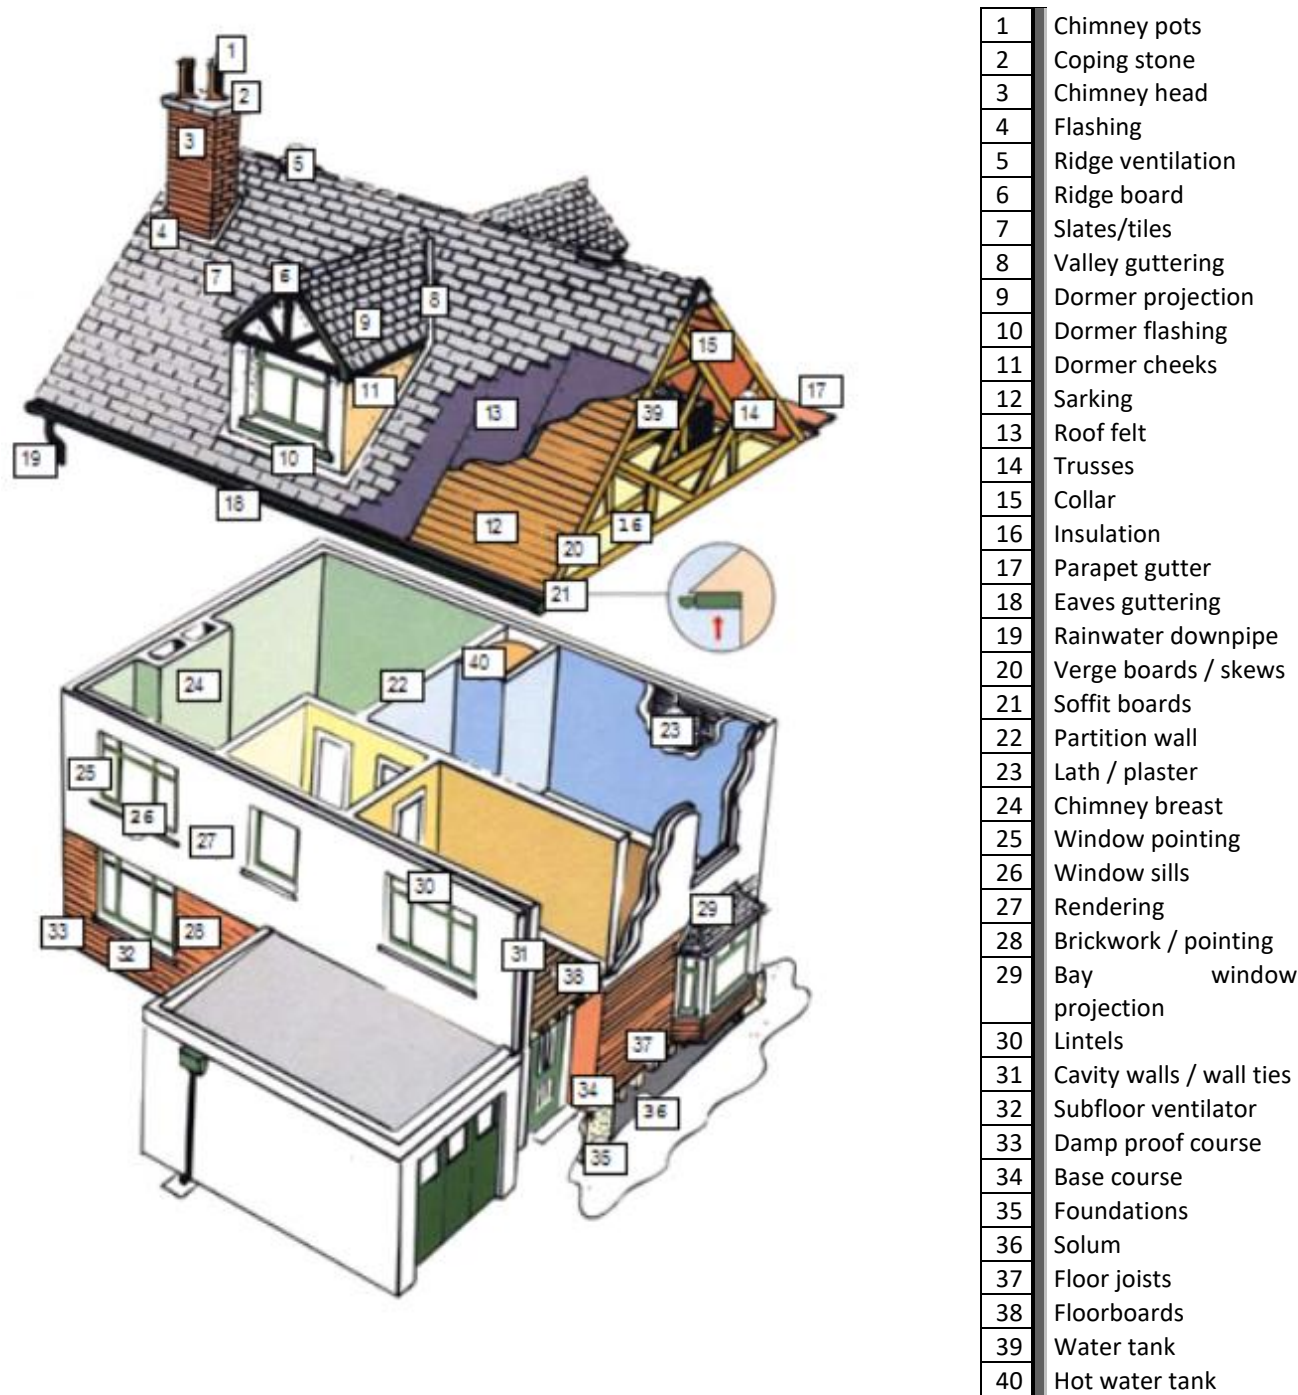
### Sectional Diagram showing elements of a typical house

Reference may be made in this report to some or all of the above component parts of the property. This diagram may assist you in locating and understanding these items.
