SINGLE SURVEY  
ENERGY REPORT  
PROPERTY QUESTIONNAIRE  
VALUATION REPORT

# Single Survey

survey report on:

| Property address | Flat 2,<br>2-4 Montague Row,<br>Inverness,<br>IV3 5DX |

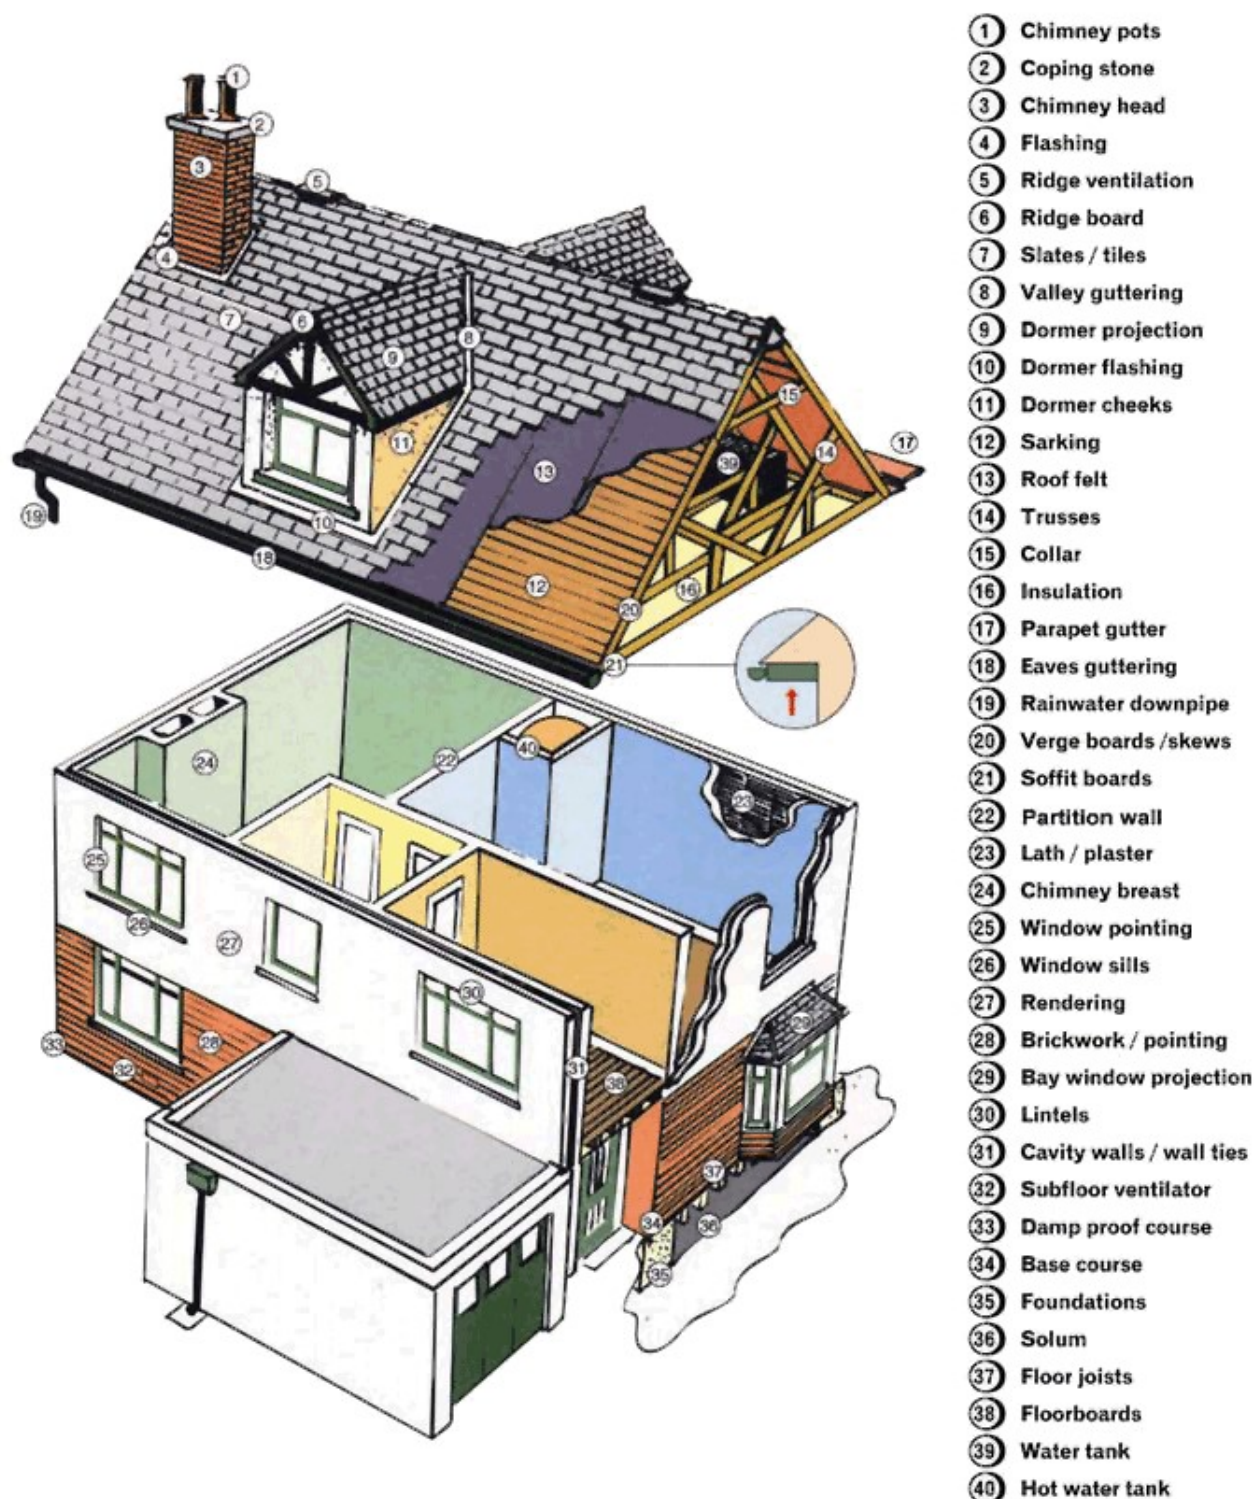
## Sectional Diagram showing elements of a typical house

Reference may be made in this report to some or all of the above component parts of the property. This diagram may assist you in locating and understanding these items.
