# Single Survey

| Property address | 58F Linkfield Road (NOS. 58 - 96)<br>Windsor Park,<br>MUSSELBURGH<br>EH21 7NT |
| Prepared by | ALLIED SURVEYORS SCOTLAND PLC |
| Date of inspection | 15th September 2021 |

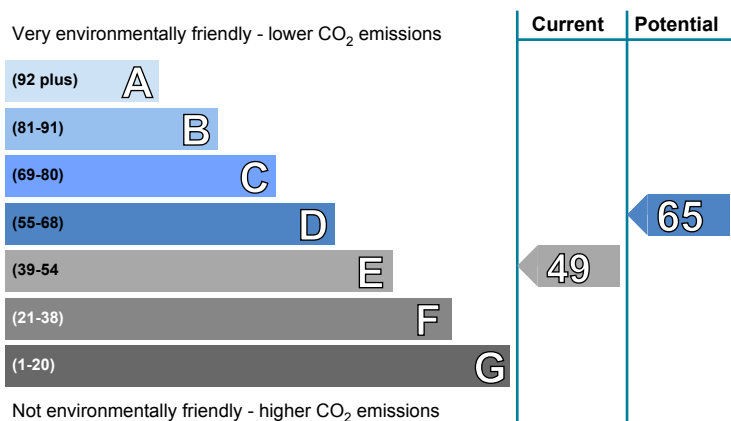
## Environmental Impact (CO<sub>2</sub>) Rating

This graph shows the effect of your home on the environment in terms of carbon dioxide (CO<sub>2</sub>) emissions. The higher the rating, the less impact it has on the environment.
