# Home Report

Property: **5/1  
206 Eldon Street  
Greenock  
Inverclyde  
PA16 7BF**

Report reference: **1194388-1-2**

Date of Report: **28/05/2021**

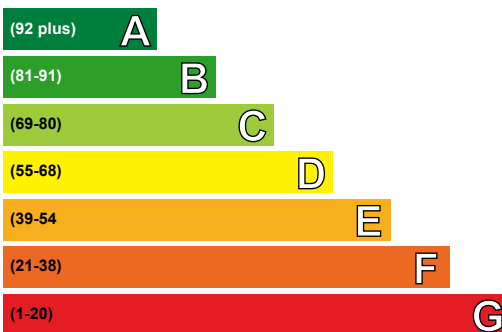
## Energy Efficiency Rating

Very energy efficient - lower running costs

Not energy efficient - higher running costs

| Current | Potential |
| 81 | 81 |

The potential rating shows the effect of undertaking all of the improvement measures listed within your recommendations report.
