# Single Survey

survey report on:

| Property address | GROUND FLOOR FLAT<br>38 ERSKINE STREET<br>ABERDEEN<br>AB24 3NQ |

| Prepared by | DM Hall LLP |

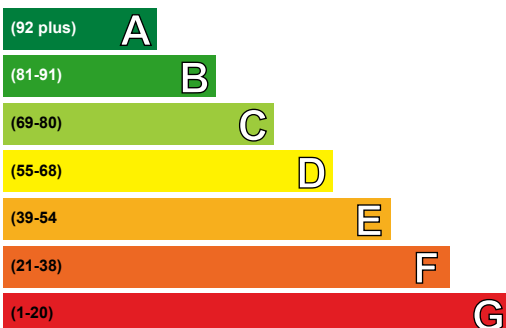
\* based upon the cost of energy for heating, hot water, lighting and ventilation, calculated using standard assumptions

Very energy efficient - lower running costs

Not energy efficient - higher running costs

The potential rating shows the effect of undertaking all of the improvement measures listed within your recommendations report.

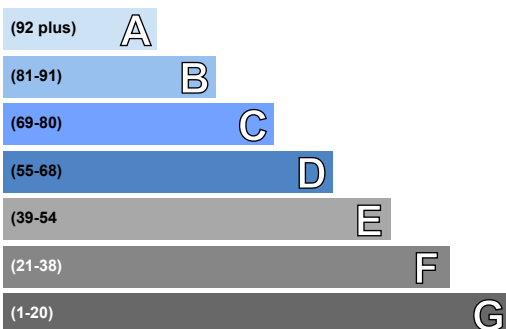
Very environmentally friendly - lower CO<sub>2</sub> emissions

Not environmentally friendly - higher CO<sub>2</sub> emissions
