# Single Survey

| <b>Property address</b> | Ground Floor Left<br>226 Victoria Road<br>Aberdeen<br>AB11 9NR |
| <b>Prepared by</b> | ALLIED SURVEYORS SCOTLAND PLC |
| <b>Date of inspection</b> | 20th May 2021 |

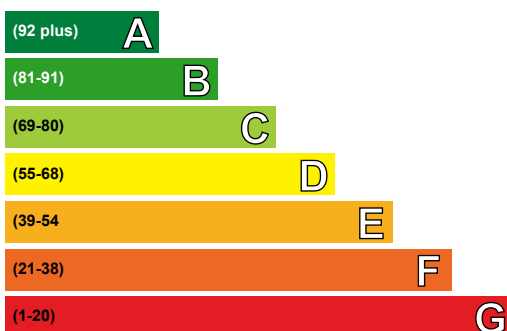
\* based upon the cost of energy for heating, hot water, lighting and ventilation, calculated using standard assumptions

Very energy efficient - lower running costs

Not energy efficient - higher running costs

The potential rating shows the effect of undertaking all of the improvement measures listed within your recommendations report.

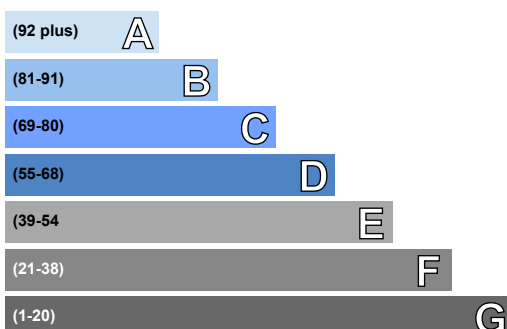
Very environmentally friendly - lower CO<sub>2</sub> emissions

Not environmentally friendly - higher CO<sub>2</sub> emissions
