# Home Report

Top Floor Right  
23 Lamond Place  
Aberdeen  
AB25 3UT

# **Single Survey and Mortgage Valuation Report**

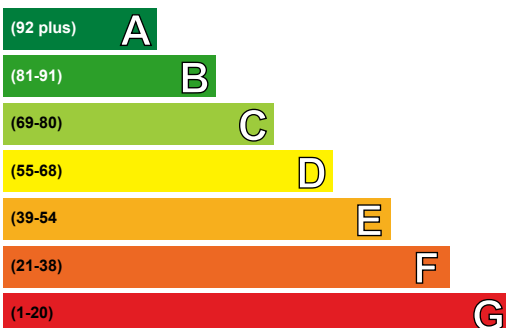
\* based upon the cost of energy for heating, hot water, lighting and ventilation, calculated using standard assumptions

Very energy efficient - lower running costs

Not energy efficient - higher running costs

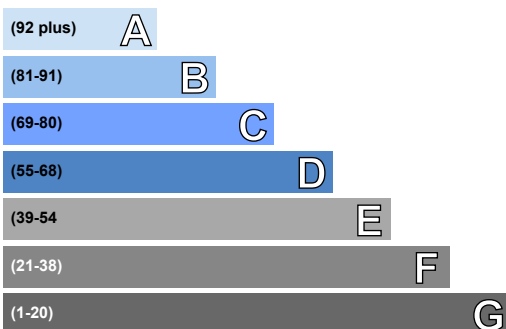
The potential rating shows the effect of undertaking all of the improvement measures listed within your recommendations report.

Very environmentally friendly - lower CO<sub>2</sub> emissions

Not environmentally friendly - higher CO<sub>2</sub> emissions
