# HOME REPORT

1 HATTON LODGE  
HATTON FARM ROAD, HATTON  
PETERHEAD  
AB42 0LN

# Energy Performance Certificate (EPC)

# Single Survey

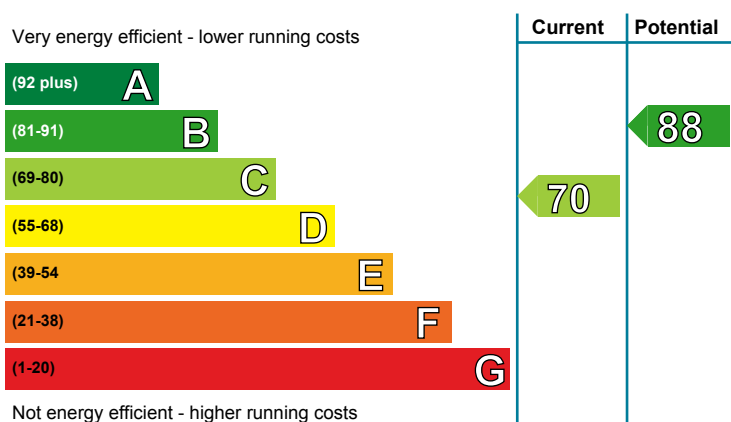
## Energy Efficiency Rating

This graph shows the current efficiency of your home, taking into account both energy efficiency and fuel costs. The higher this rating, the lower your fuel bills are likely to be.

Your current rating is **band C (70)**. The average rating for EPCs in Scotland is **band D (61)**.

The potential rating shows the effect of undertaking all of the improvement measures listed within your recommendations report.

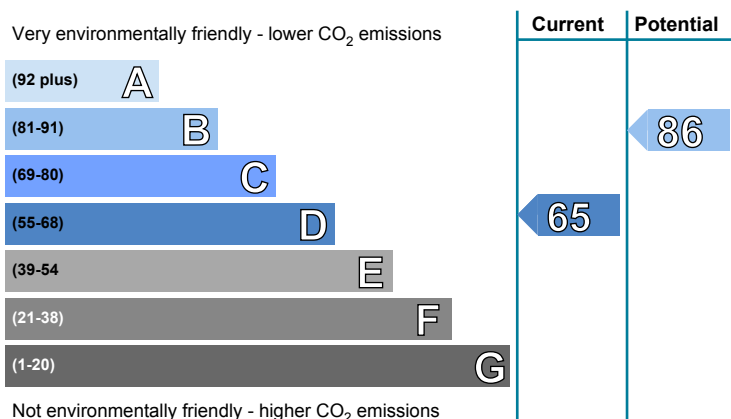
## Environmental Impact (CO<sub>2</sub>) Rating

This graph shows the effect of your home on the environment in terms of carbon dioxide (CO<sub>2</sub>) emissions. The higher the rating, the less impact it has on the environment.

Your current rating is **band D (65)**. The average rating for EPCs in Scotland is **band D (59)**.

The potential rating shows the effect of undertaking all of the improvement measures listed within your recommendations report.
