Home Report

Property: **West View
49 Dunkeld Road
Perth
Perth And Kinross
PH1 5RP**

Energy Performance Certificate (EPC)

WESTVIEW, 49 DUNKELD ROAD, PERTH, PH1 5RP

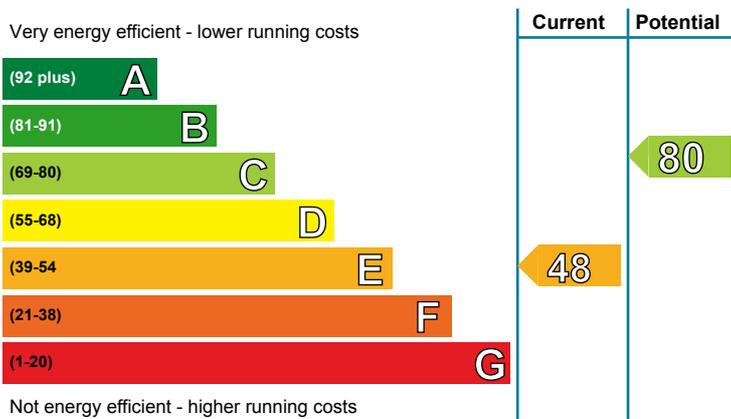
Energy Efficiency Rating

This graph shows the current efficiency of your home, taking into account both energy efficiency and fuel costs. The higher this rating, the lower your fuel bills are likely to be.

Your current rating is **band E (48)**. The average rating for EPCs in Scotland is **band D (61)**.

The potential rating shows the effect of undertaking all of the improvement measures listed within your recommendations report.

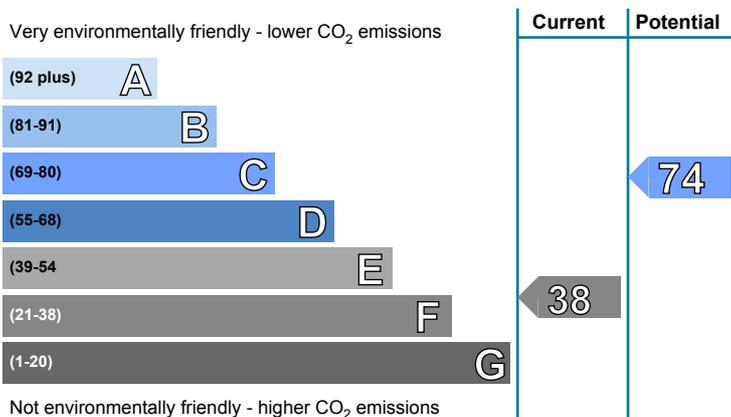
Environmental Impact (CO₂) Rating

This graph shows the effect of your home on the environment in terms of carbon dioxide (CO₂) emissions. The higher the rating, the less impact it has on the environment.

The potential rating shows the effect of undertaking all of the improvement measures listed within your recommendations report.

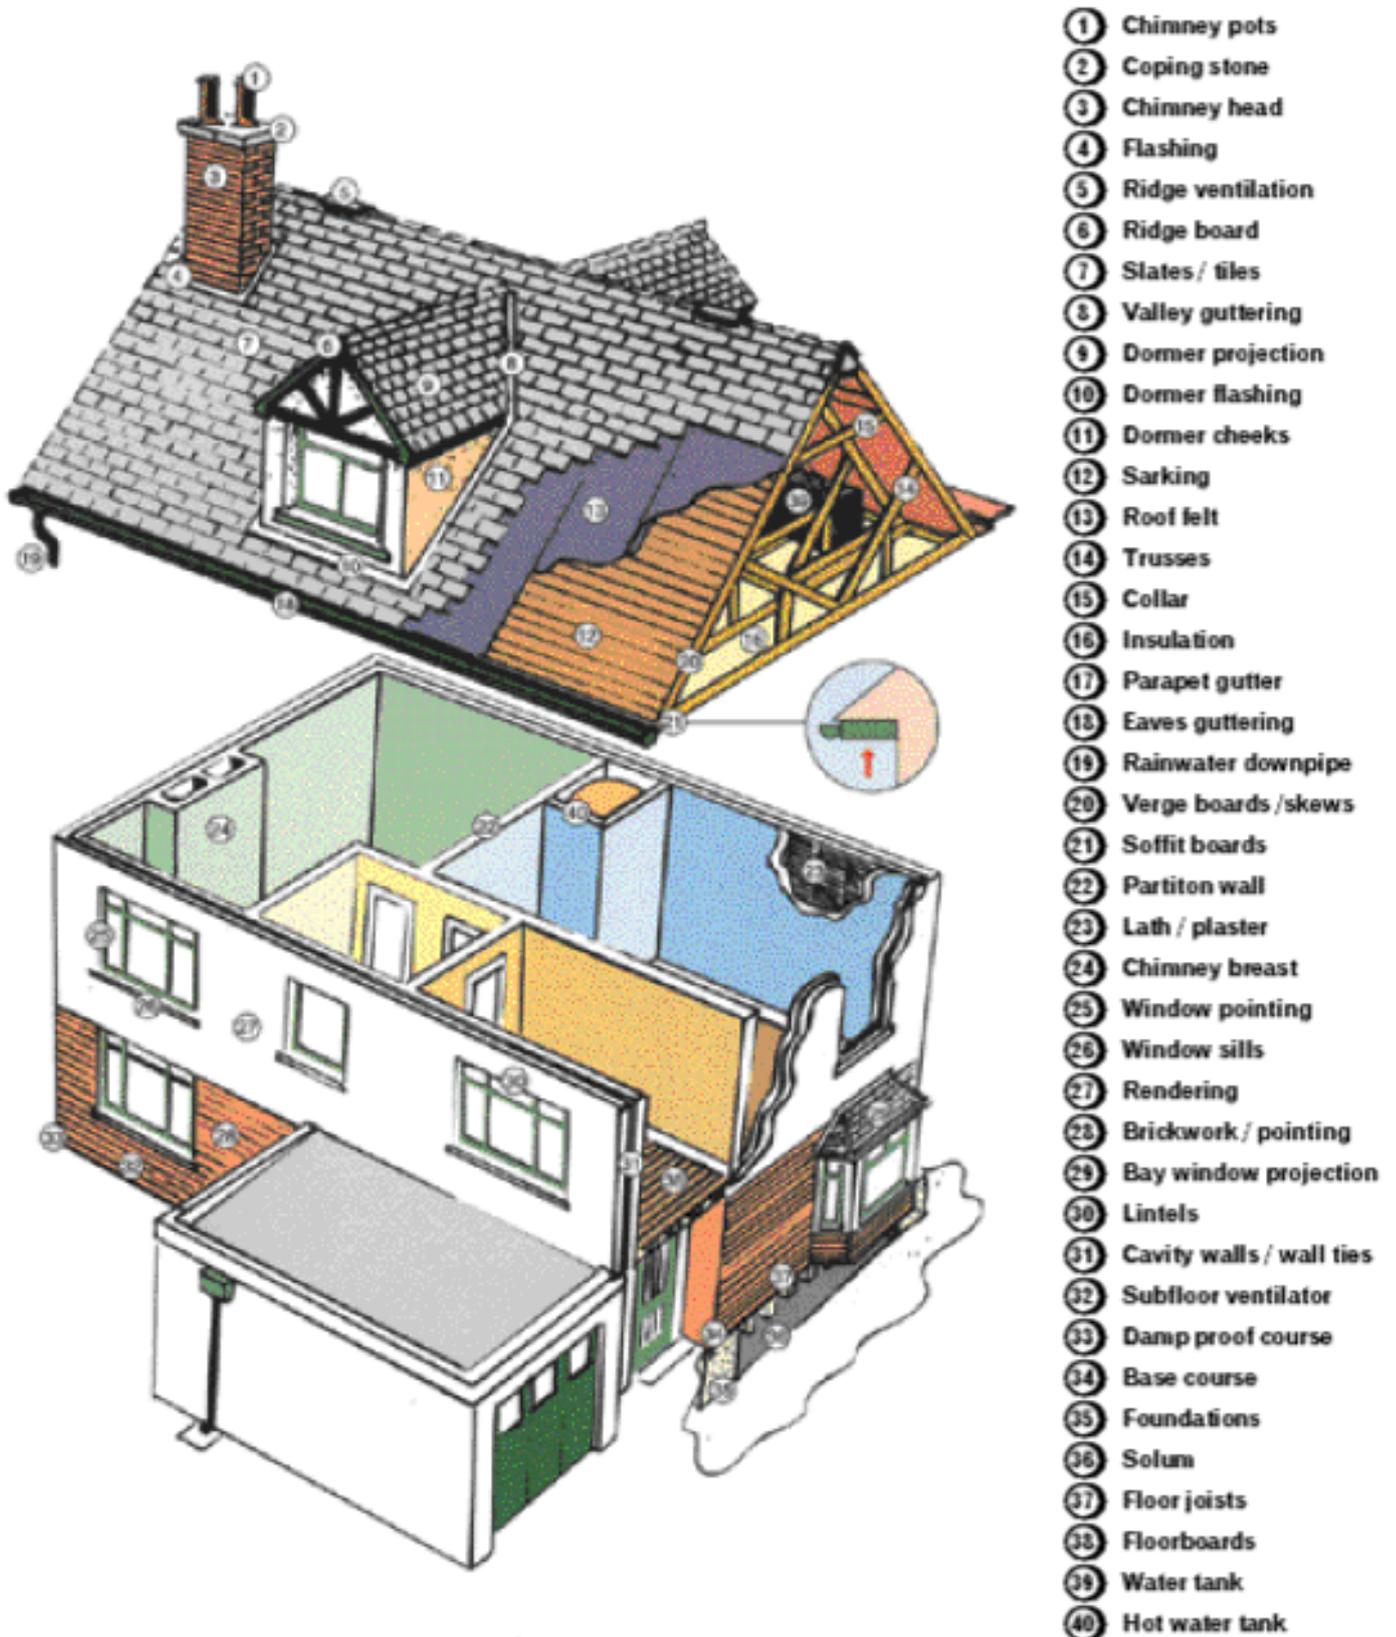
▷ Sectional diagram showing elements of a typical house:

Reference may be made in this report to some or all of the above component parts of the property. This diagram may assist you in locating and understanding these terms.
