HOME REPORT

34 CLOAN CRESCENT
BISHOPBRIGGS
GLASGOW
G64 2HL

DM HALL
CHARTERED SURVEYORS

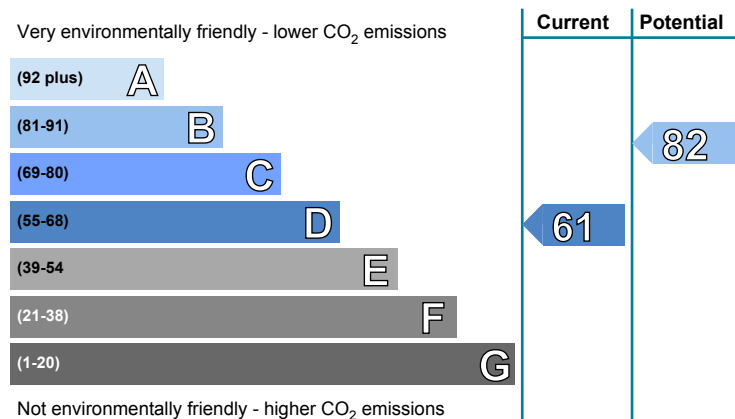
Environmental Impact (CO₂) Rating

This graph shows the effect of your home on the environment in terms of carbon dioxide (CO₂) emissions. The higher the rating, the less impact it has on the environment.

Your current rating is **band D (61)**. The average rating for EPCs in Scotland is **band D (59)**.

The potential rating shows the effect of undertaking all of the improvement measures listed within your recommendations report.
