# SINGLE SURVEY

# Single Survey

Survey report on:

<b>Customer</b>	Mr. Iain Carruthers
<b>Customer address</b>	4 Burnholm Road Kirkpatrick Fleming, Lockerbie DG11 3AY
<b>Date of Inspection</b>	23/06/2017
<b>Prepared by</b>	Simon Allen Dumfries - Allied Surveyors Scotland Plc

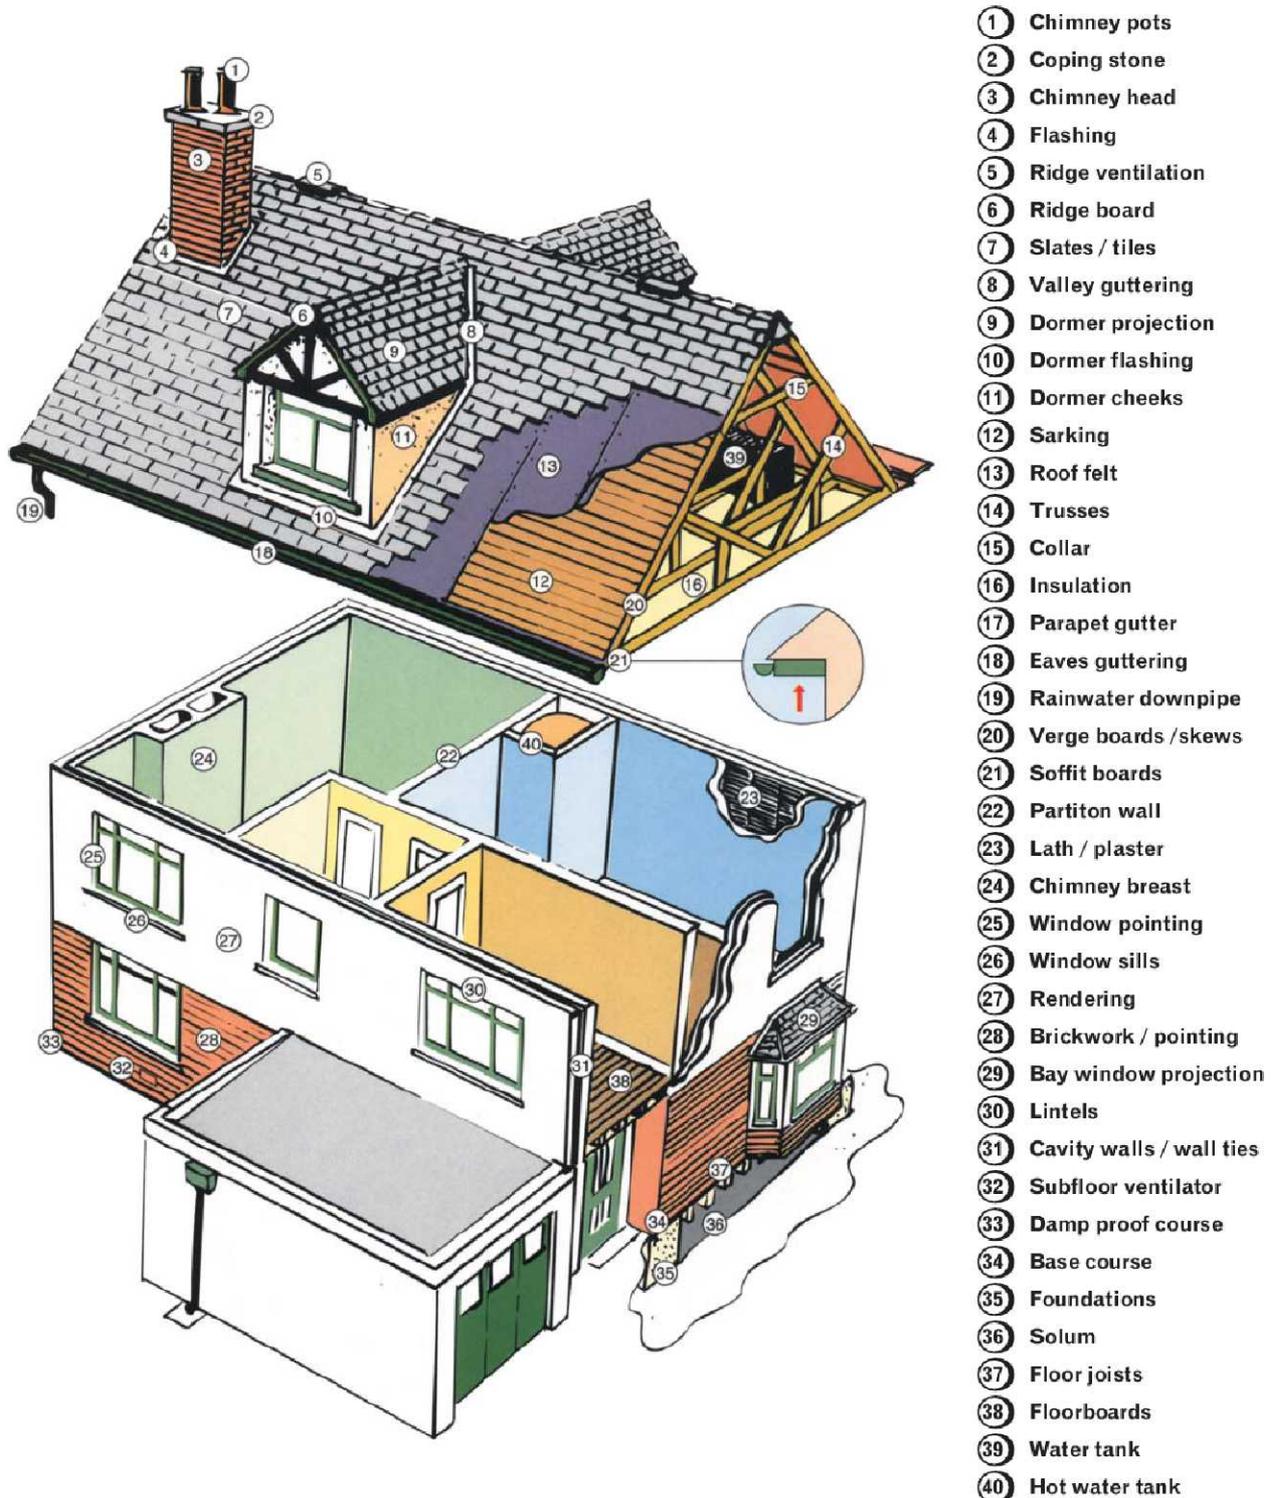
## Sectional Diagram showing elements of a typical house

- ① Chimney pots
- ② Coping stone
- ③ Chimney head
- ④ Flashing
- ⑤ Ridge ventilation
- ⑥ Ridge board
- ⑦ Slates / tiles
- ⑧ Valley guttering
- ⑨ Dormer projection
- ⑩ Dormer flashing
- ⑪ Dormer cheeks
- ⑫ Sarking
- ⑬ Roof felt
- ⑭ Trusses
- ⑮ Collar
- ⑯ Insulation
- ⑰ Parapet gutter
- ⑱ Eaves guttering
- ⑲ Rainwater downpipe
- ⑳ Verge boards /skews
- ㉑ Soffit boards
- ㉒ Partiton wall
- ㉓ Lath / plaster
- ㉔ Chimney breast
- ㉕ Window pointing
- ㉖ Window sills
- ㉗ Rendering
- ㉘ Brickwork / pointing
- ㉙ Bay window projection
- ㉚ Lintels
- ㉛ Cavity walls / wall ties
- ㉜ Subfloor ventilator
- ㉝ Damp proof course
- ㉞ Base course
- ㉟ Foundations
- ㊱ Solum
- ㊲ Floor joists
- ㊳ Floorboards
- ㊴ Water tank
- ㊵ Hot water tank

Reference may be made in this report to some or all of the above component parts of the property. This diagram may assist you in locating and understanding these items.
