# Home Report

Property: **58  
Cromwell Road  
Burntisland  
Fife  
KY3 9EH**

Report reference: **1284301-1-2**

Date of Report: **29/11/2021**

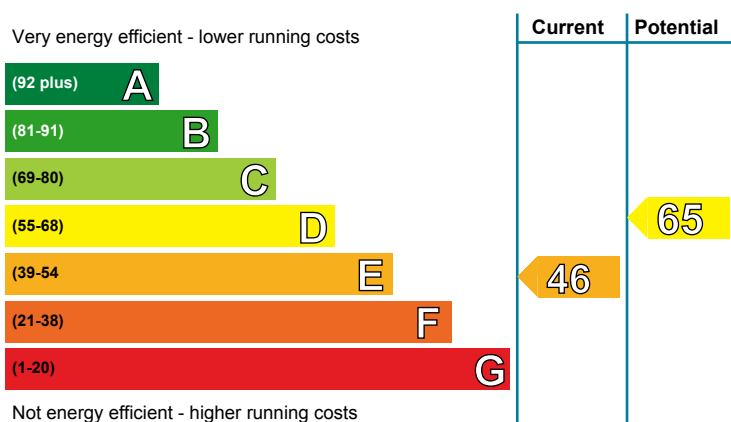
## Energy Efficiency Rating

This graph shows the current efficiency of your home, taking into account both energy efficiency and fuel costs. The higher this rating, the lower your fuel bills are likely to be.

Your current rating is **band E (46)**. The average rating for EPCs in Scotland is **band D (61)**.

The potential rating shows the effect of undertaking all of the improvement measures listed within your recommendations report.

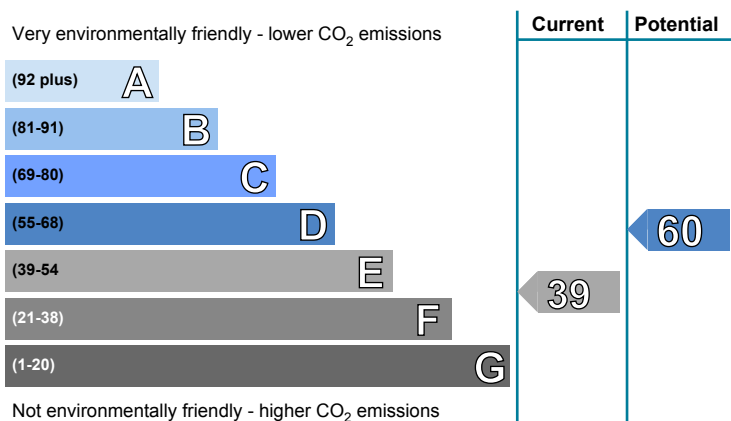
## Environmental Impact (CO<sub>2</sub>) Rating

This graph shows the effect of your home on the environment in terms of carbon dioxide (CO<sub>2</sub>) emissions. The higher the rating, the less impact it has on the environment.

The potential rating shows the effect of undertaking all of the improvement measures listed within your recommendations report.

The average Scottish household produces about 6 tonnes of carbon dioxide every year. Based on this assessment, heating and lighting this home currently produces approximately 6.7 tonnes of carbon dioxide every year. Adopting recommendations in this report can reduce emissions and protect the environment. If you were to install all of these recommendations this could reduce emissions by 2.7 tonnes per year. You could reduce emissions even more by switching to renewable energy sources.
