# Home Report

Property: **8c  
South Campbell Street  
Paisley  
Renfrewshire  
PA2 6LR**

Date of Report: **27/04/2022**

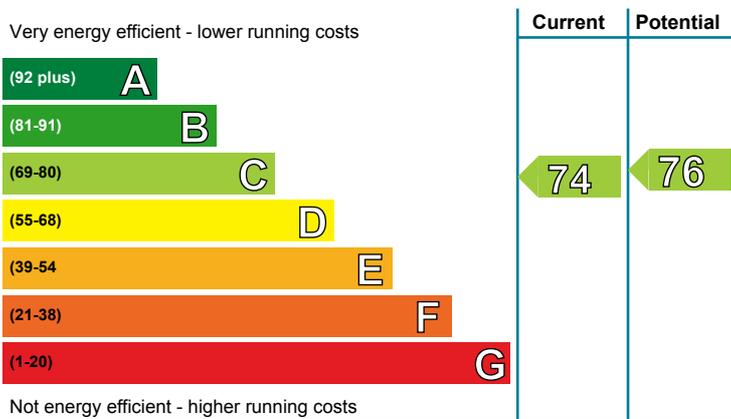
## Energy Efficiency Rating

This graph shows the current efficiency of your home, taking into account both energy efficiency and fuel costs. The higher this rating, the lower your fuel bills are likely to be.

Your current rating is **band C (74)**. The average rating for EPCs in Scotland is **band D (61)**.

The potential rating shows the effect of undertaking all of the improvement measures listed within your recommendations report.

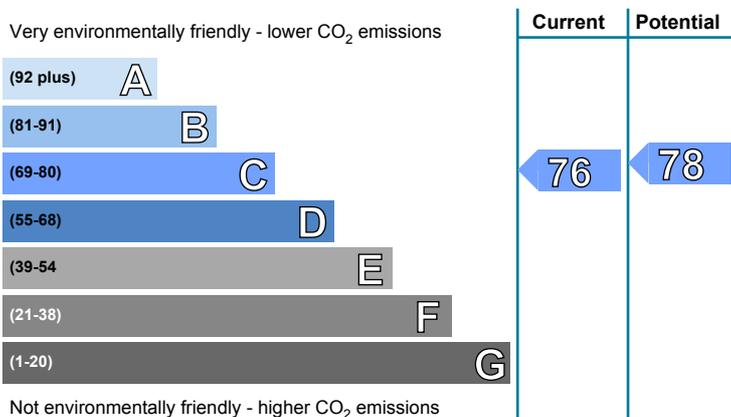
## Environmental Impact (CO<sub>2</sub>) Rating

This graph shows the effect of your home on the environment in terms of carbon dioxide (CO<sub>2</sub>) emissions. The higher the rating, the less impact it has on the environment.

The potential rating shows the effect of undertaking all of the improvement measures listed within your recommendations report.
