# Home Report

33 Simpson Road  
Aberdeen  
AB23 8EP

# **Single Survey and Mortgage Valuation Report**

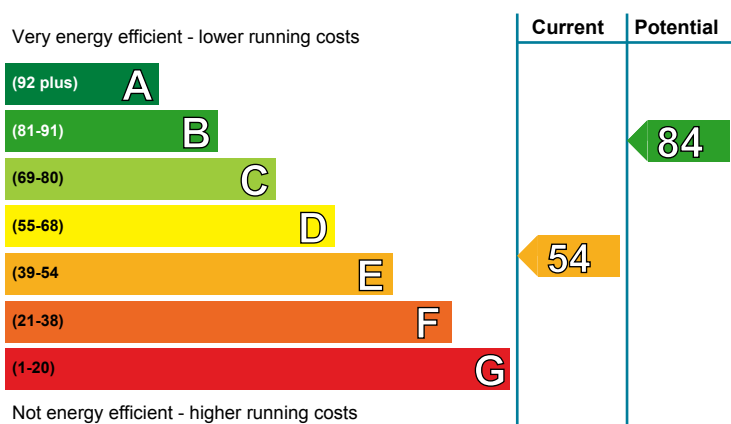
## Energy Efficiency Rating

This graph shows the current efficiency of your home, taking into account both energy efficiency and fuel costs. The higher this rating, the lower your fuel bills are likely to be.

Your current rating is **band E (54)**. The average rating for EPCs in Scotland is **band D (61)**.

The potential rating shows the effect of undertaking all of the improvement measures listed within your recommendations report.

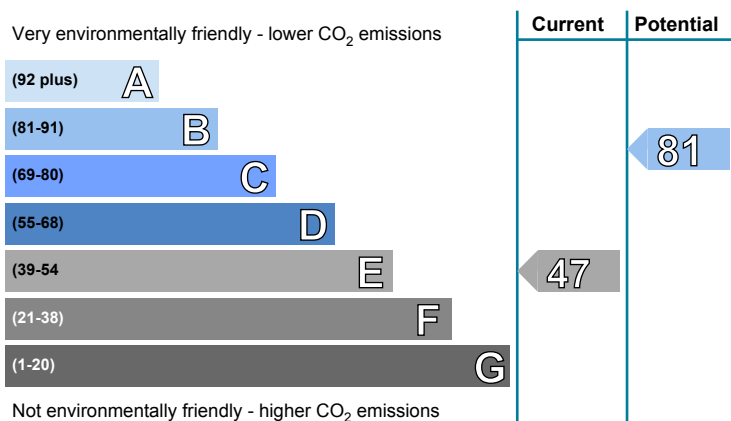
## Environmental Impact (CO<sub>2</sub>) Rating

This graph shows the effect of your home on the environment in terms of carbon dioxide (CO<sub>2</sub>) emissions. The higher the rating, the less impact it has on the environment.
