HOME REPORT

# Energy Performance Certificate

47 Preston Road, Linlithgow, EH49 6HG

## Single Survey

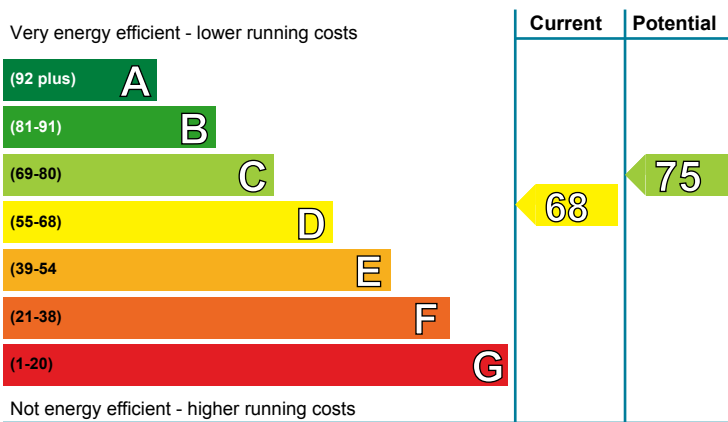
## Energy Efficiency Rating

This graph shows the current efficiency of your home, taking into account both energy efficiency and fuel costs. The higher this rating, the lower your fuel bills are likely to be.

Your current rating is **band D (68)**. The average rating for EPCs in Scotland is **band D (61)**.

The potential rating shows the effect of undertaking all of the improvement measures listed within your recommendations report.

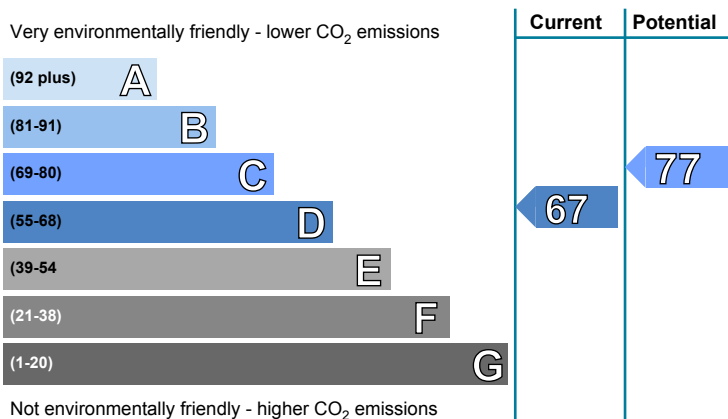
## Environmental Impact (CO<sub>2</sub>) Rating

This graph shows the effect of your home on the environment in terms of carbon dioxide (CO<sub>2</sub>) emissions. The higher the rating, the less impact it has on the environment.

Your current rating is **band D (67)**. The average rating for EPCs in Scotland is **band D (59)**.

The potential rating shows the effect of undertaking all of the improvement measures listed within your recommendations report.
