HOME REPORT

FLAT 8 , 10 CALDER GROVE, EDINBURGH, EH11 4NA

## Single Survey

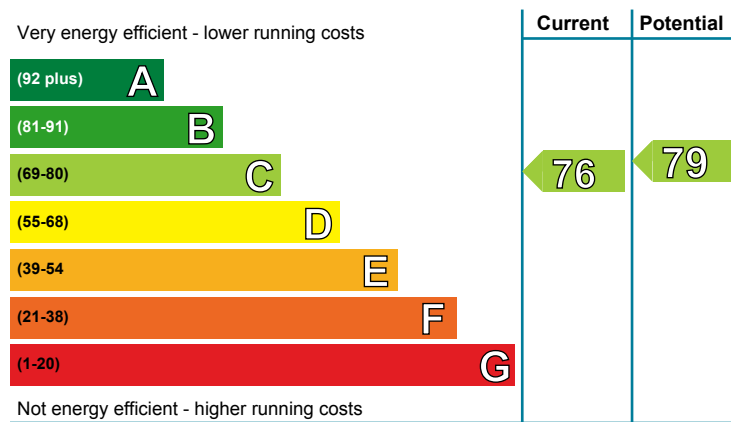
## Energy Efficiency Rating

This graph shows the current efficiency of your home, taking into account both energy efficiency and fuel costs. The higher this rating, the lower your fuel bills are likely to be.

Your current rating is **band C (76)**. The average rating for EPCs in Scotland is **band D (61)**.

The potential rating shows the effect of undertaking all of the improvement measures listed within your recommendations report.

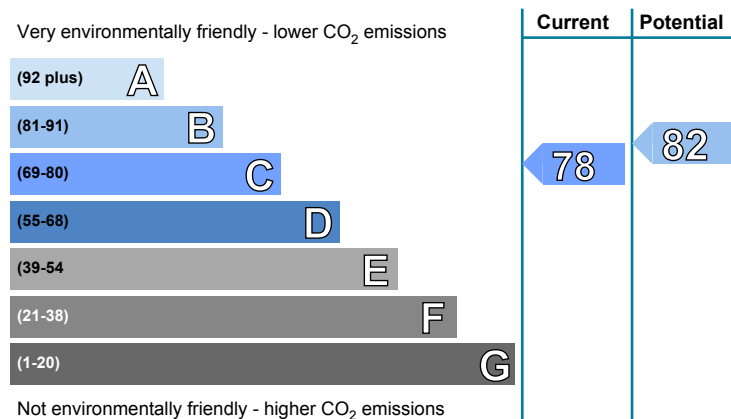
## Environmental Impact (CO<sub>2</sub>) Rating

This graph shows the effect of your home on the environment in terms of carbon dioxide (CO<sub>2</sub>) emissions. The higher the rating, the less impact it has on the environment.

Your current rating is **band C (78)**. The average rating for EPCs in Scotland is **band D (59)**.

The potential rating shows the effect of undertaking all of the improvement measures listed within your recommendations report.
