YOUR ONESURVEY  
**HOME REPORT**

80 Main Street  
Tomintoul, Ballindalloch  
AB37 9HA

# SINGLE SURVEY

A report on the condition of the property, with categories  
being rated from 1 to 3.

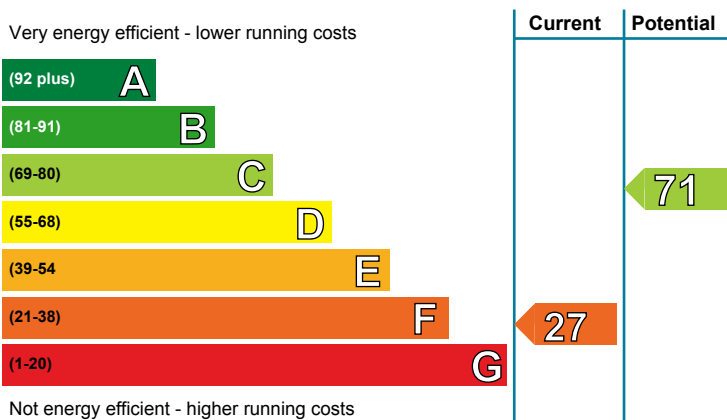
## Energy Efficiency Rating

This graph shows the current efficiency of your home, taking into account both energy efficiency and fuel costs. The higher this rating, the lower your fuel bills are likely to be.

Your current rating is **band F (27)**. The average rating for EPCs in Scotland is **band D (61)**.

The potential rating shows the effect of undertaking all of the improvement measures listed within your recommendations report.

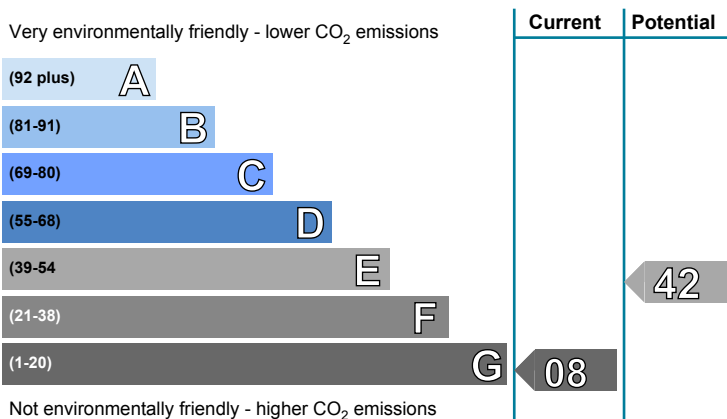
## Environmental Impact (CO<sub>2</sub>) Rating

This graph shows the effect of your home on the environment in terms of carbon dioxide (CO<sub>2</sub>) emissions. The higher the rating, the less impact it has on the environment.
