# Home Report

Property: **Sunningdale  
Mollanbowie Road  
Alexandria  
Argyll And Bute  
G83 8LU**

Report reference: **1573641-1-2**

Date of Report: **07/09/2023**

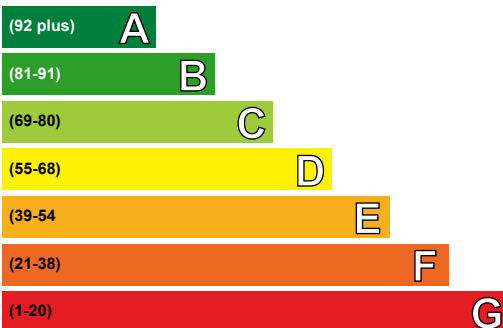
| Current | Potential |
| 34 | 78 |

The potential rating shows the effect of undertaking all of the improvement measures listed within your recommendations report.

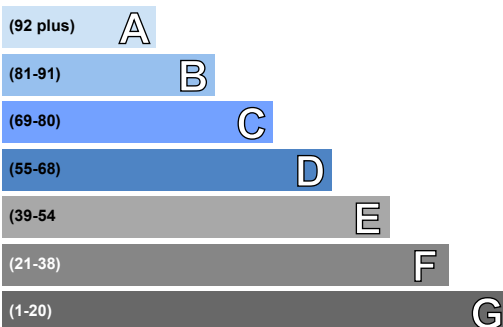
| Current | Potential |
| 34 | 50 |

The potential rating shows the effect of undertaking all of the improvement measures listed within your recommendations report.

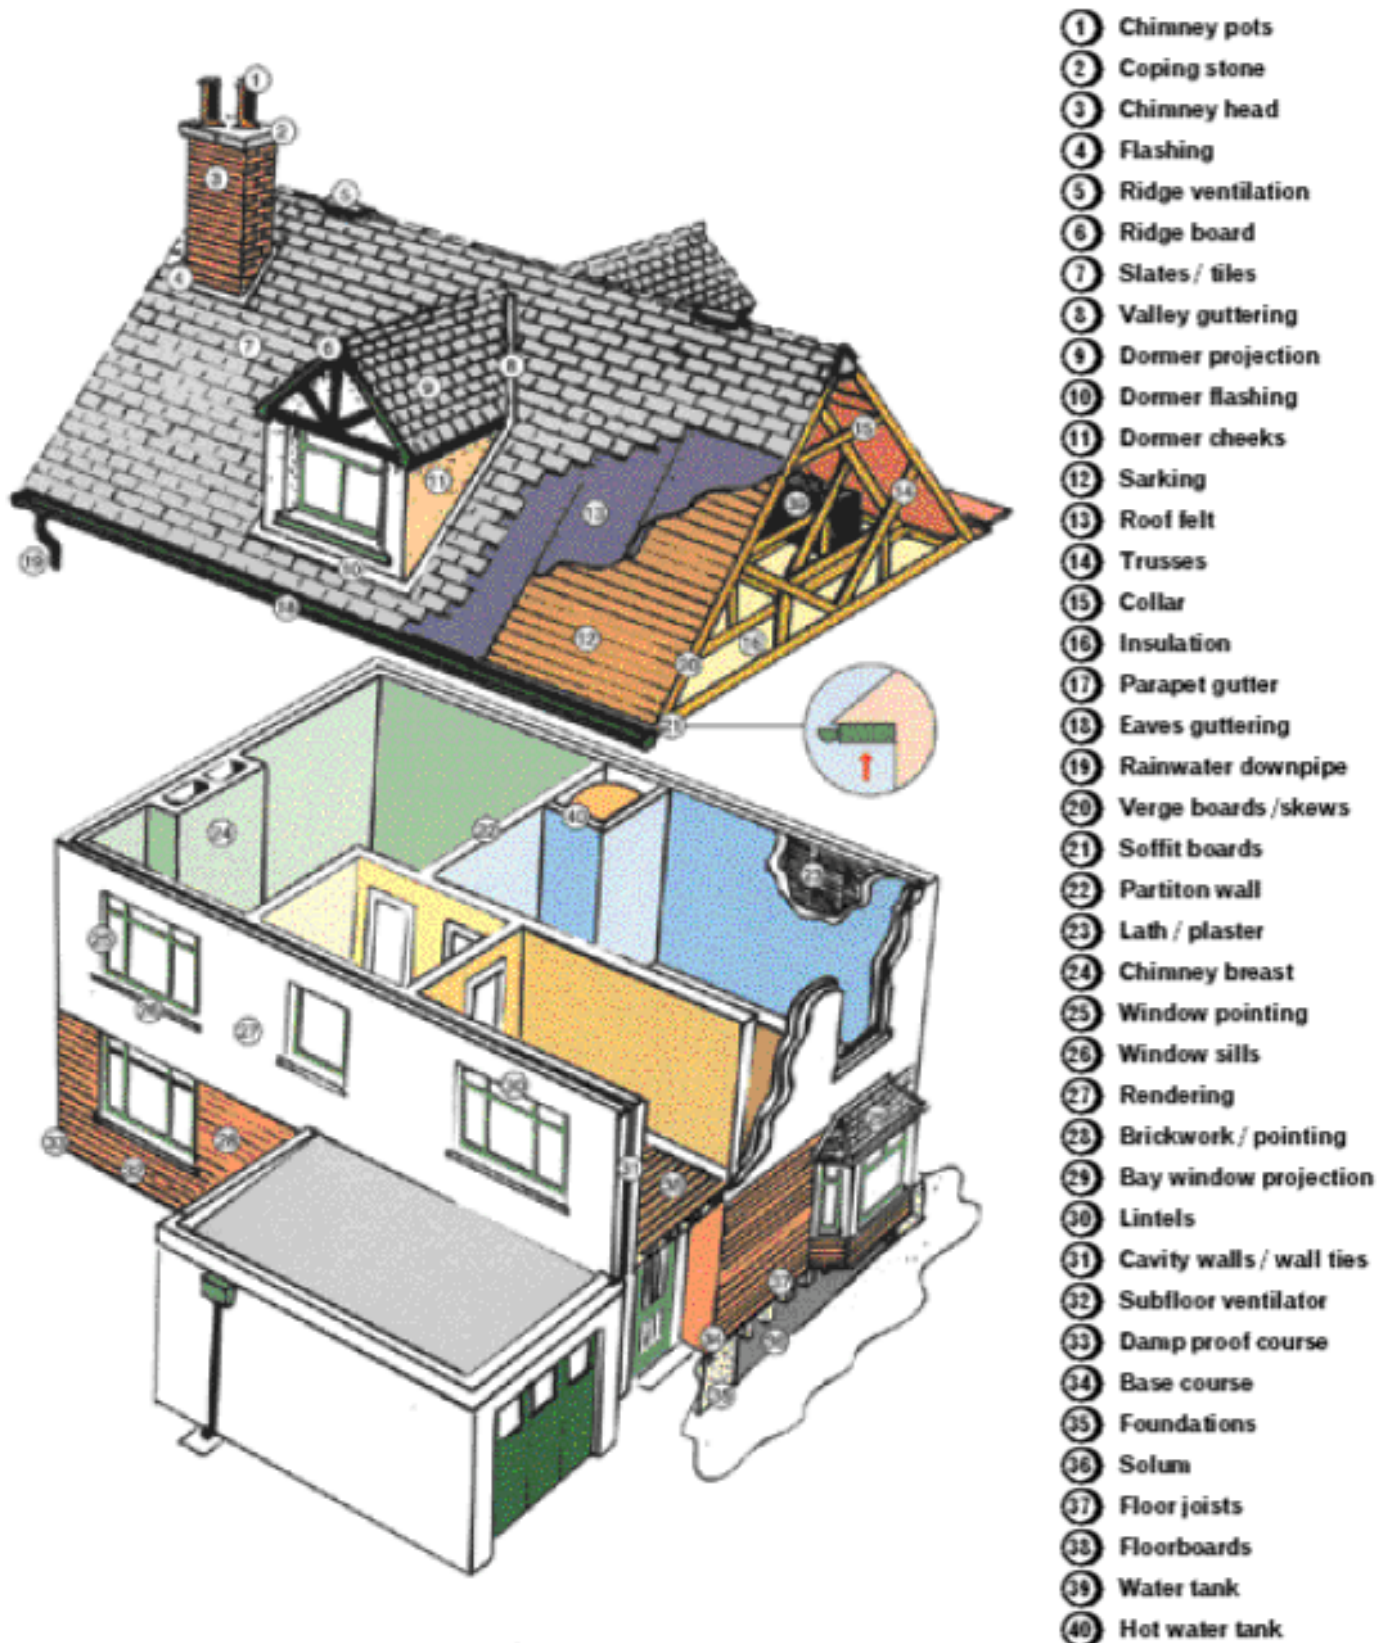
▷ Sectional diagram showing elements of a typical house:

Reference may be made in this report to some or all of the above component parts of the property. This diagram may assist you in locating and understanding these terms.
