## Home Report

Property: **3g  
Dundonald Road  
Troon  
Ayrshire  
KA10 6NP**

Report reference: **1582104-1-2**

Date of Report: **25/10/2023**

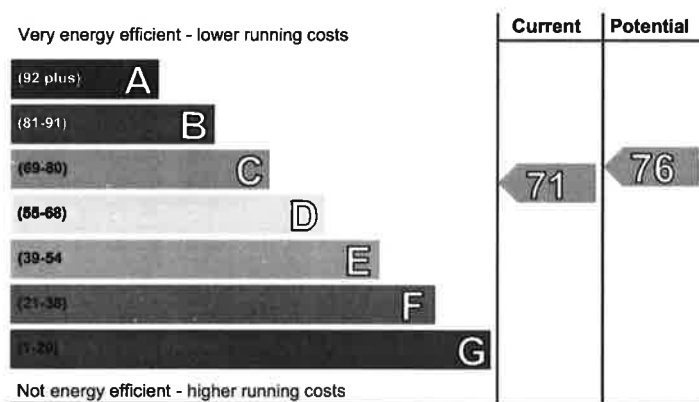
## Energy Efficiency Rating

This graph shows the current efficiency of your home, taking into account both energy efficiency and fuel costs. The higher this rating, the lower your fuel bills are likely to be.

Your current rating is **band C (71)**. The average rating for EPCs in Scotland is **band D (61)**.

The potential rating shows the effect of undertaking all of the improvement measures listed within your recommendations report.

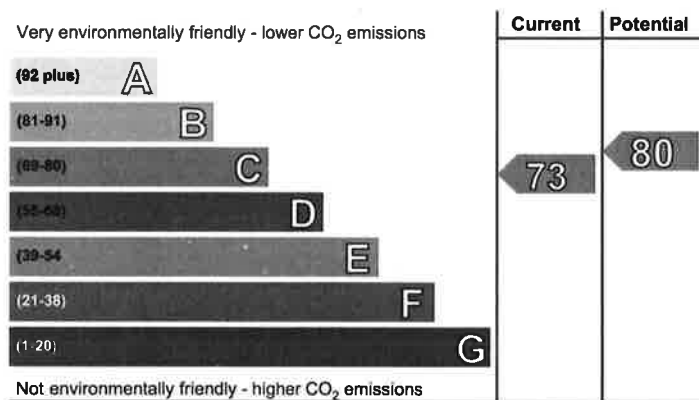
## Environmental Impact (CO<sub>2</sub>) Rating

This graph shows the effect of your home on the environment in terms of carbon dioxide (CO<sub>2</sub>) emissions. The higher the rating, the less impact it has on the environment.

The potential rating shows the effect of undertaking all of the improvement measures listed within your recommendations report.

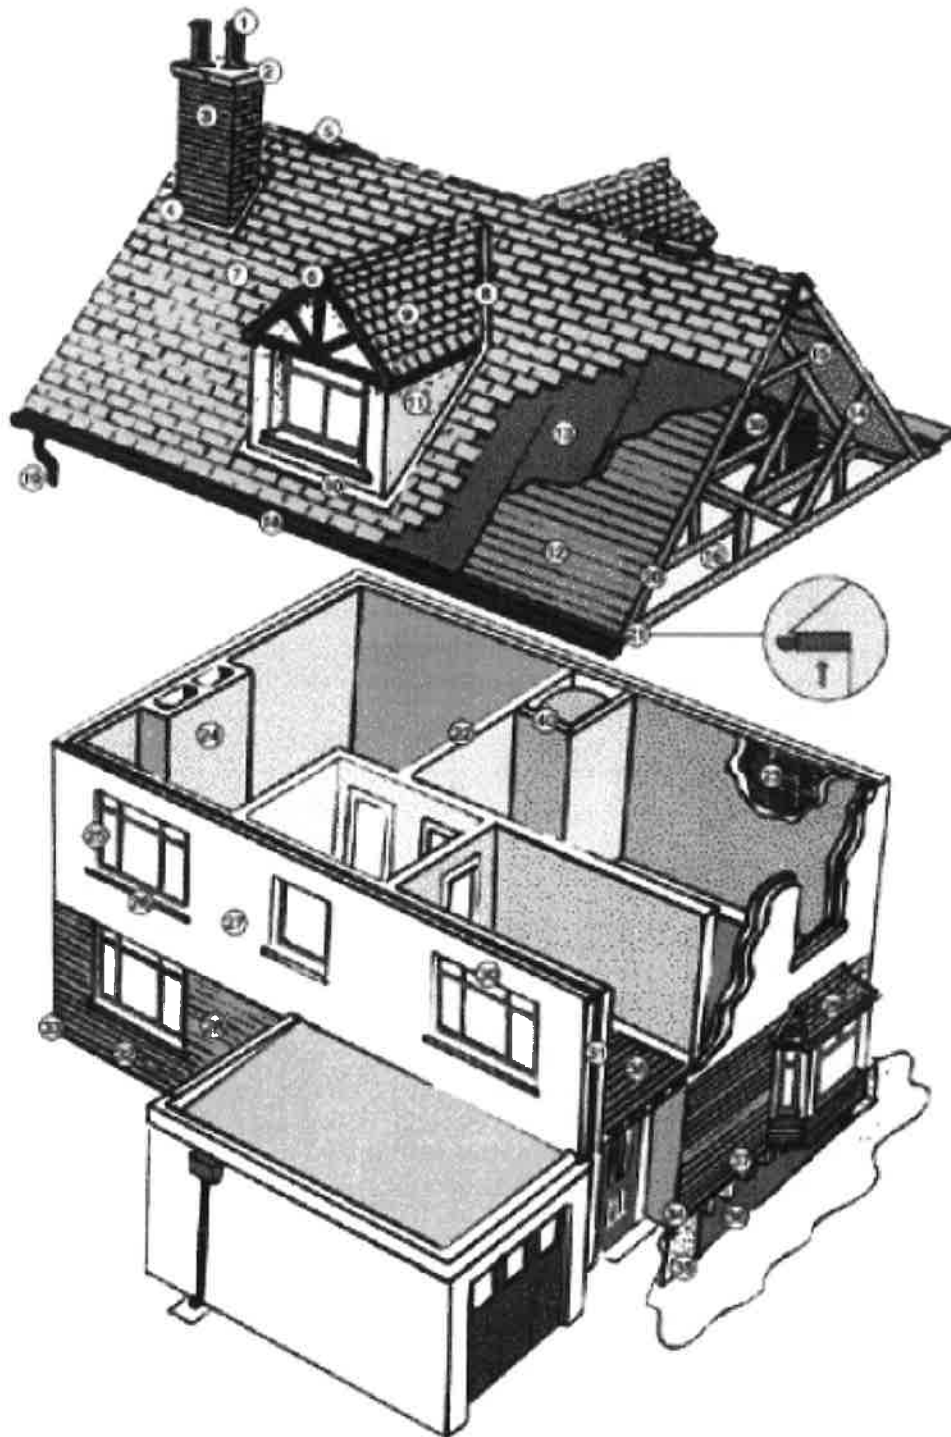
▷ Sectional diagram showing elements of a typical house:

- ① Chimney pots
- ② Coping stone
- ③ Chimney head
- ④ Flashing
- ⑤ Ridge ventilation
- ⑥ Ridge board
- ⑦ Slates / tiles
- ⑧ Valley guttering
- ⑨ Dormer projection
- ⑩ Dormer flashing
- ⑪ Dormer cheeks
- ⑫ Sarking
- ⑬ Roof felt
- ⑭ Trusses
- ⑮ Collar
- ⑯ Insulation
- ⑰ Parapet gutter
- ⑱ Eaves guttering
- ⑲ Rainwater downpipe
- ⑳ Verge boards /skews
- ㉑ Soffit boards
- ㉒ Partiton wall
- ㉓ Lath / plaster
- ㉔ Chimney breast
- ㉕ Window pointing
- ㉖ Window sills
- ㉗ Rendering
- ㉘ Brickwork / pointing
- ㉙ Bay window projection
- ㉚ Lintels
- ㉛ Cavity walls / wall ties
- ㉜ Subfloor ventilator
- ㉝ Damp proof course
- ㉞ Base course
- ㉟ Foundations
- ㊱ Solum
- ㊲ Floor joists
- ㊳ Floorboards
- ㊴ Water tank
- ㊵ Hot water tank

Reference may be made in this report to some or all of the above component parts of the property. This diagram may assist you in locating and understanding these terms.
