Survey Report

**Glengarth,
Maxwell Road,
Langholm
DG13 0DX**

Date of inspection: 14th January, 2016

**Prepared by: Andrew H R Crossan FRICS
A H R Crossan and Co.,
41a Castle Street,
Dumfries
DG1 1DU**

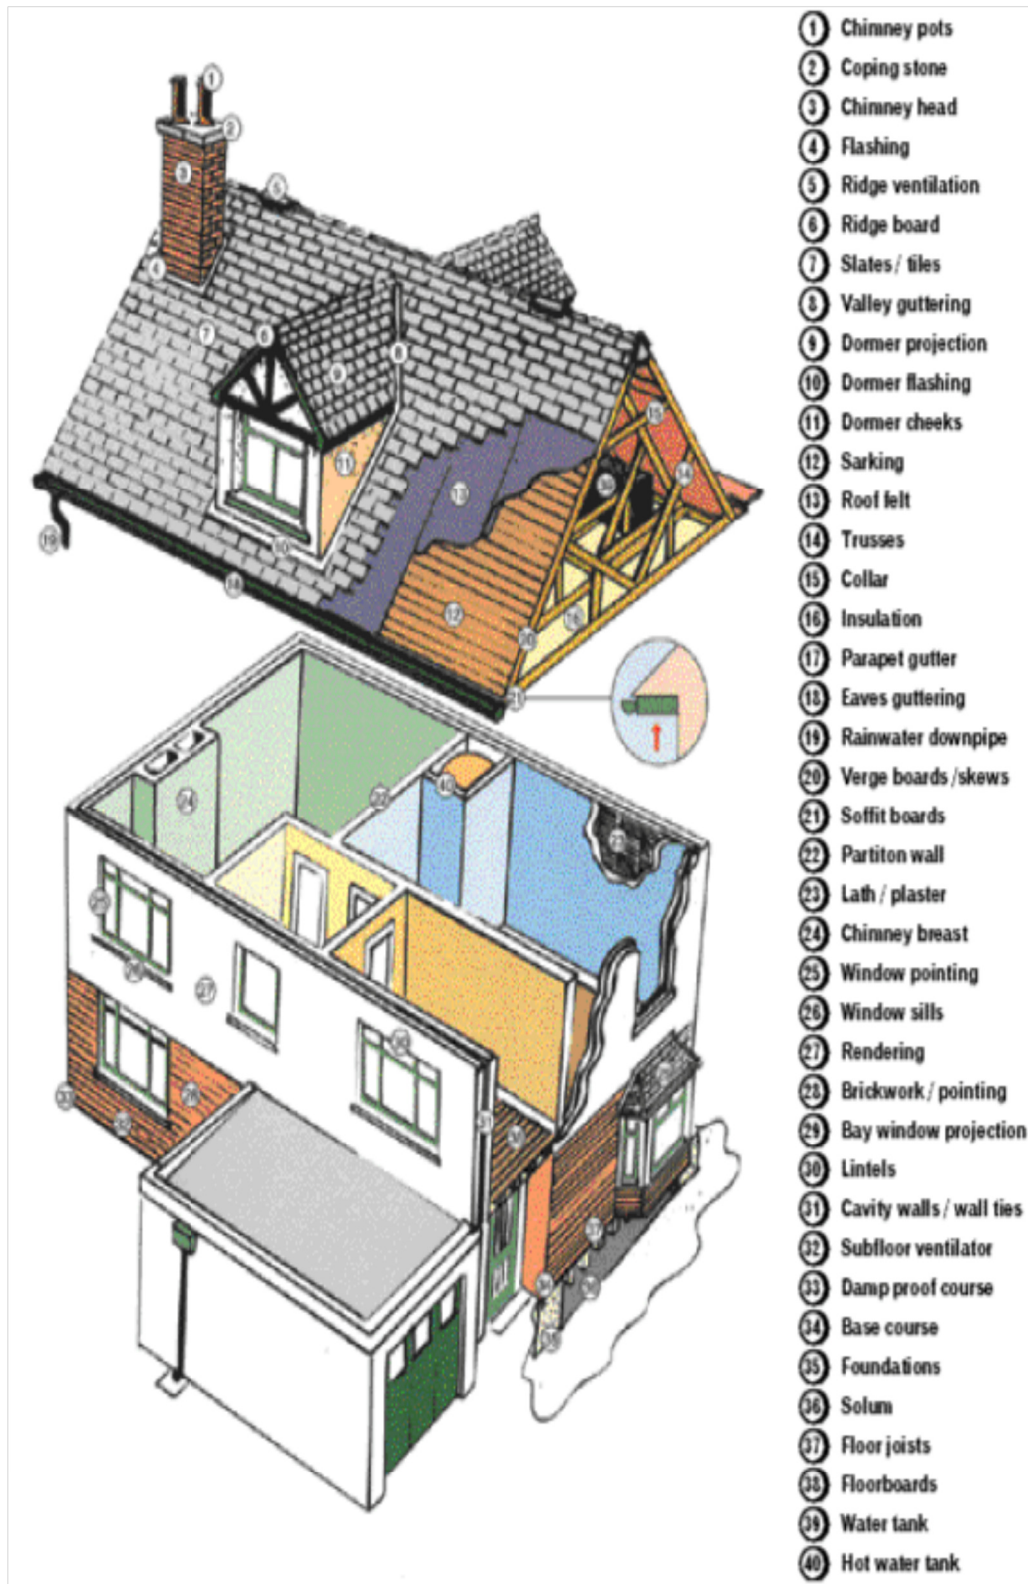
Sectional diagram showing elements of a typical house

Reference may be made in this report to some or all of the above component parts of the property. This diagram may assist you in locating and understanding these terms.
