# Home Report

Property: **25e  
Hepburn Street  
Dundee  
Angus  
DD3 8BR**

Report reference: **1596032-1-2**

Date of Report: **01/02/2024**

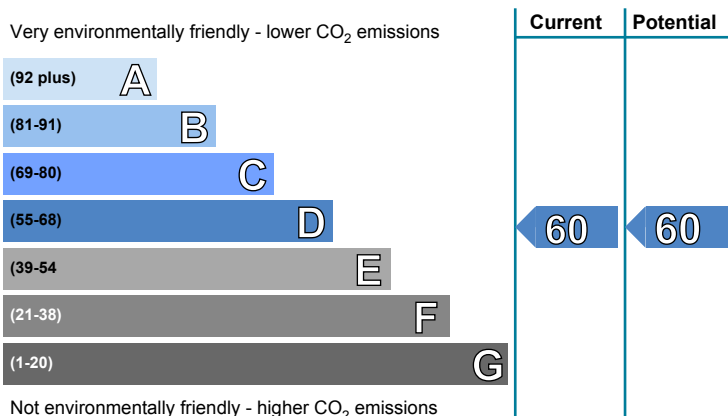
## Environmental Impact (CO<sub>2</sub>) Rating

This graph shows the effect of your home on the environment in terms of carbon dioxide (CO<sub>2</sub>) emissions. The higher the rating, the less impact it has on the environment.

The potential rating shows the effect of undertaking all of the improvement measures listed within your recommendations report.
