# Home Report

Flat A  
10 Carmelite Street  
Aberdeen  
AB11 6NL

# **Single Survey and Mortgage Valuation Report**

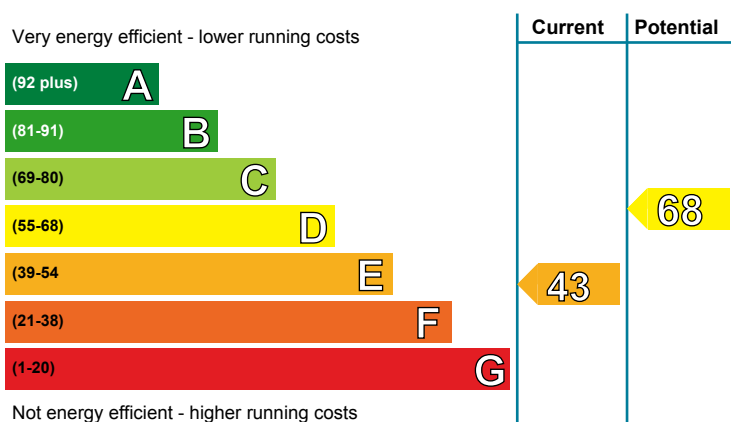
## Energy Efficiency Rating

This graph shows the current efficiency of your home, taking into account both energy efficiency and fuel costs. The higher this rating, the lower your fuel bills are likely to be.

Your current rating is **band E (43)**. The average rating for EPCs in Scotland is **band D (61)**.

The potential rating shows the effect of undertaking all of the improvement measures listed within your recommendations report.

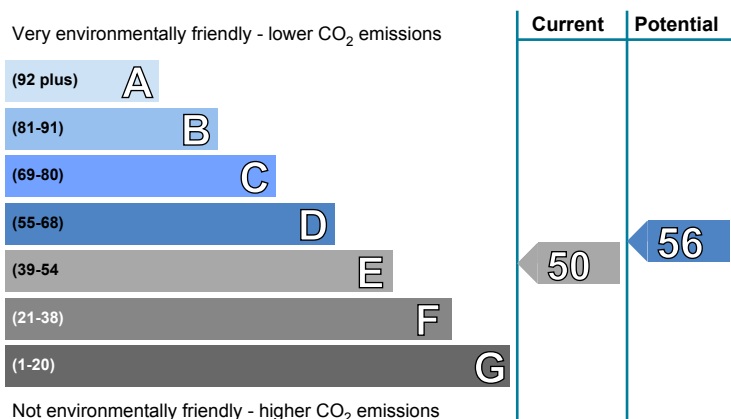
## Environmental Impact (CO<sub>2</sub>) Rating

This graph shows the effect of your home on the environment in terms of carbon dioxide (CO<sub>2</sub>) emissions. The higher the rating, the less impact it has on the environment.
