# Home Report

Flat 17 Trinity House  
Trinity Quay  
Aberdeen  
AB11 5AA

# **Single Survey and Mortgage Valuation Report**

| <b>Date of inspection</b> | 18th September 2024 |

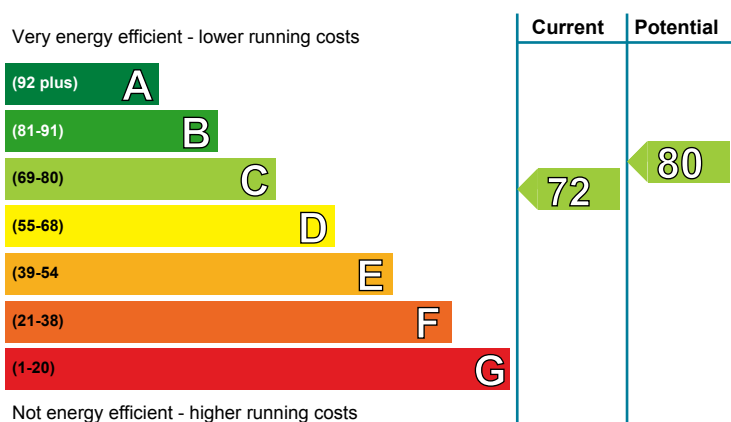
## Energy Efficiency Rating

This graph shows the current efficiency of your home, taking into account both energy efficiency and fuel costs. The higher this rating, the lower your fuel bills are likely to be.

Your current rating is **band C (72)**. The average rating for EPCs in Scotland is **band D (61)**.

The potential rating shows the effect of undertaking all of the improvement measures listed within your recommendations report.

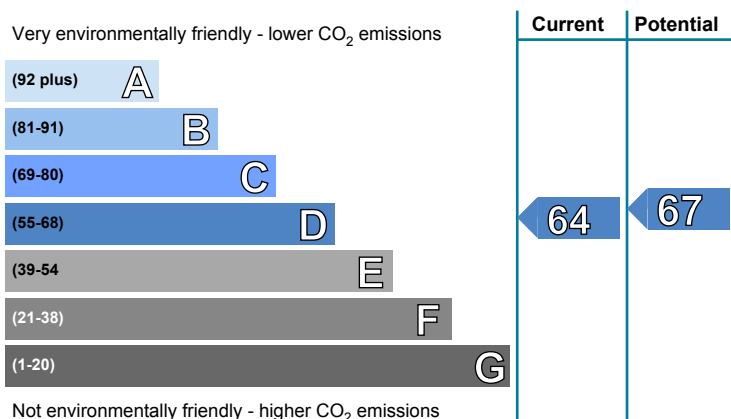
## Environmental Impact (CO<sub>2</sub>) Rating

This graph shows the effect of your home on the environment in terms of carbon dioxide (CO<sub>2</sub>) emissions. The higher the rating, the less impact it has on the environment.
