294 Lanark Road West,  
Currie,  
Midlothian,  
EH14 5RU

# Home Report

# Single Survey

| <b>Property Address</b> | 294 Lanark Road West,<br>Currie,<br>Midlothian,<br>EH14 5RU |

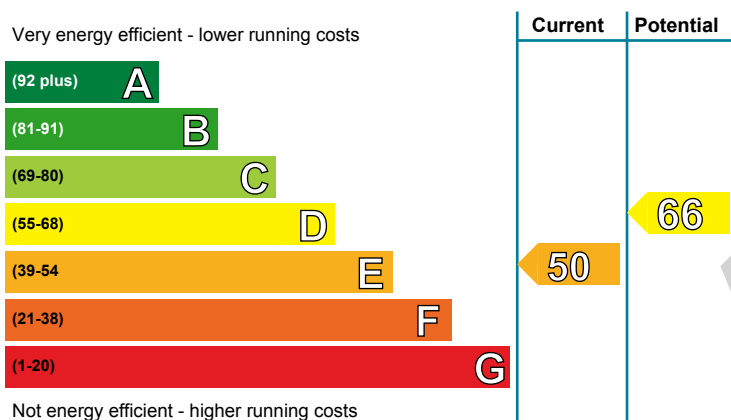
## Energy Efficiency Rating

This graph shows the current efficiency of your home, taking into account both energy efficiency and fuel costs. The higher this rating, the lower your fuel bills are likely to be.

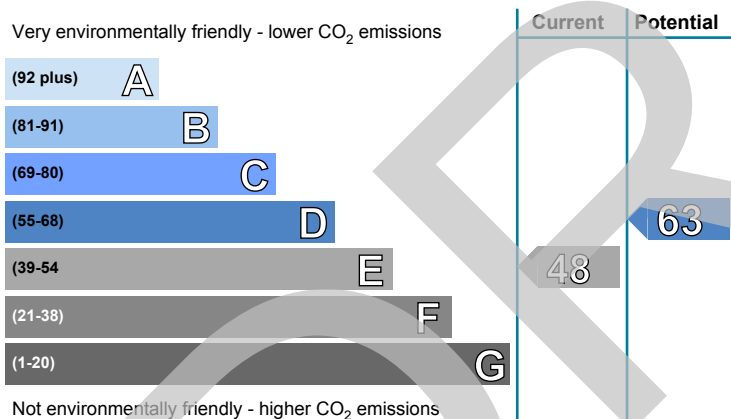
## Environmental Impact (CO<sub>2</sub>) Rating

This graph shows the effect of your home on the environment in terms of carbon dioxide (CO<sub>2</sub>) emissions. The higher the rating, the less impact it has on the environment.
