# Home Report

Property:           **14**  
                          **Lindsay Gardens**  
                          **Bathgate**  
                          **West Lothian**  
                          **EH48 1DU**

Report reference: **2094320-1-2**

Date of Report:     **21/05/2026**

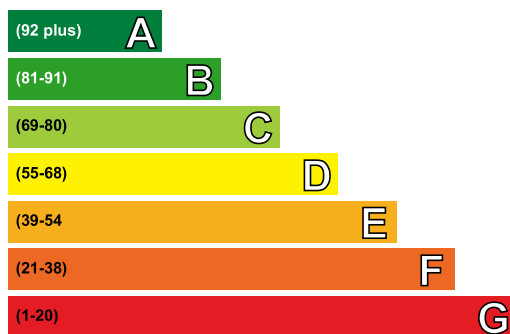
Very energy efficient - lower running costs

Not energy efficient - higher running costs

| Current | Potential |
| 82 | 82 |

## Energy Efficiency Rating

The potential rating shows the effect of undertaking all of the improvement measures listed within your recommendations report.

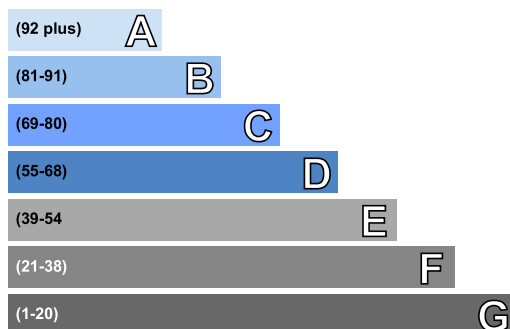
Very environmentally friendly - lower CO<sub>2</sub> emissions

Not environmentally friendly - higher CO<sub>2</sub> emissions

| Current | Potential |

The potential rating shows the effect of undertaking all of the improvement measures listed within your recommendations report.

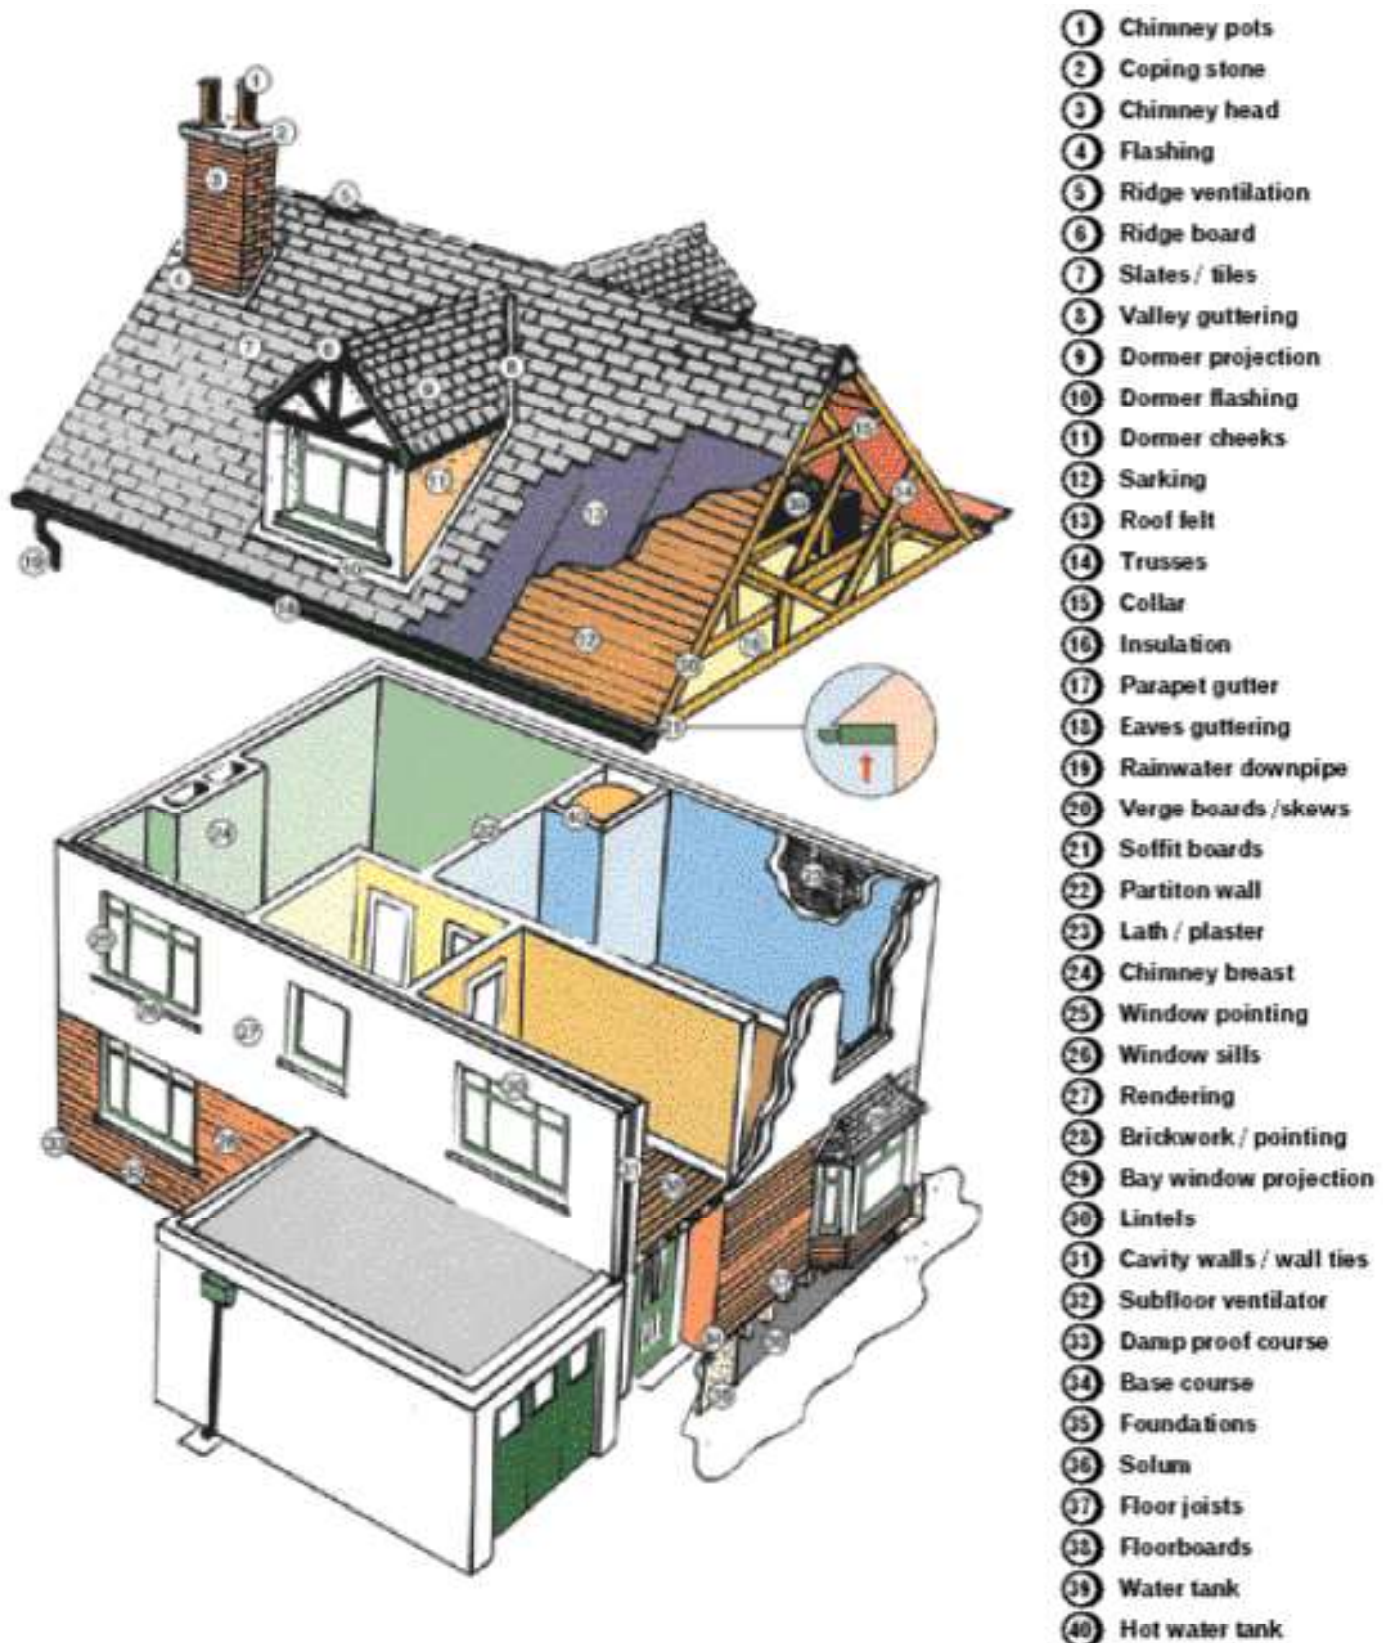
▷ Sectional diagram showing elements of a typical house:

Reference may be made in this report to some or all of the above component parts of the property. This diagram may assist you in locating and understanding these terms.
