# Home Report

Property:           **33  
Duff Street  
Macduff  
Moray  
AB44 1QJ**

Report reference: **2120790-1-2**

# Energy Performance Certificate (EPC)

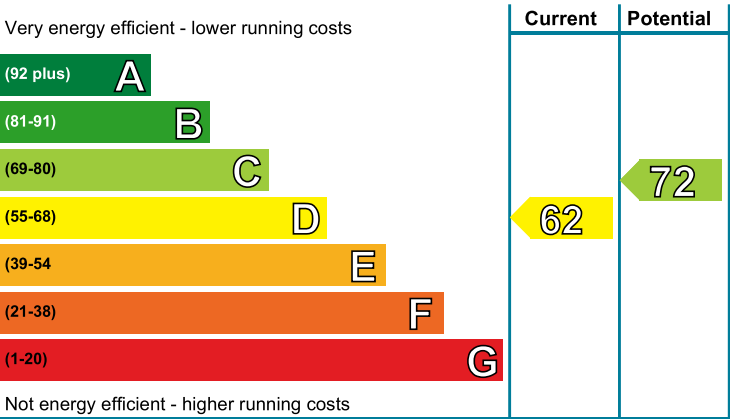
**Energy Efficiency Rating**

This graph shows the current efficiency of your home, taking into account both energy efficiency and fuel costs. The higher this rating, the lower your fuel bills are likely to be.

Your current rating is **band D (62)**. The average rating for EPCs in Scotland is **band D (61)**.

The potential rating shows the effect of undertaking all of the improvement measures listed within your recommendations report.

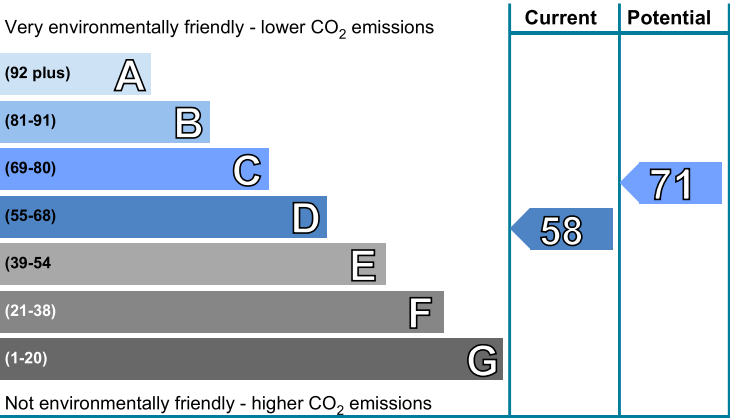
**Environmental Impact (CO<sub>2</sub>) Rating**

This graph shows the effect of your home on the environment in terms of carbon dioxide (CO<sub>2</sub>) emissions. The higher the rating, the less impact it has on the environment.

The potential rating shows the effect of undertaking all of the improvement measures listed within your recommendations report.
