71b High Street

single survey

Survey report on:

Description	Double upper flat formed by the conversion of a four storey
	Victorian period style building.

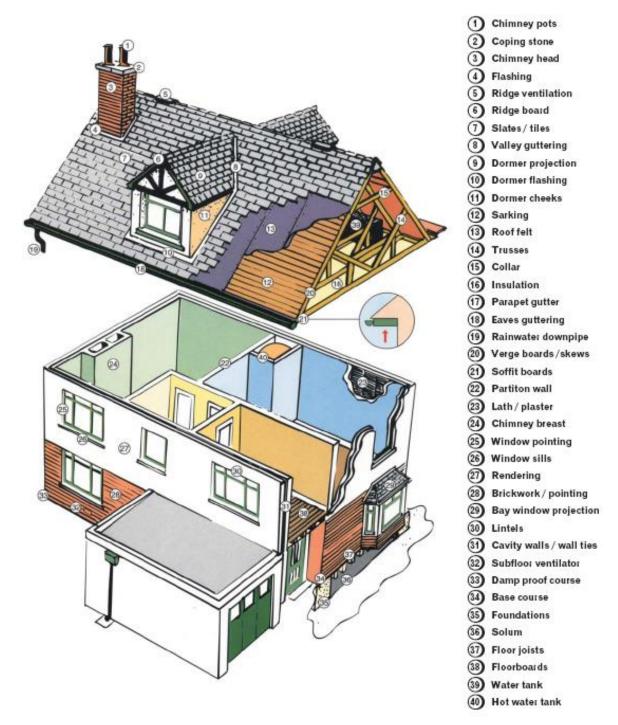
Sectional Diagram showing elements of a typical house

Reference may be made in this report to some or all of the above component parts of the property. This diagram may assist you in locating and understanding these items.
