Home Report

97 Craigielea Road
Clydebank
G81 6LA

single survey

Property address	97 Craigielea Road Clydebank G81 6LA
Customer	Ross Graham
Prepared by	Dominic McCormick, MRICS

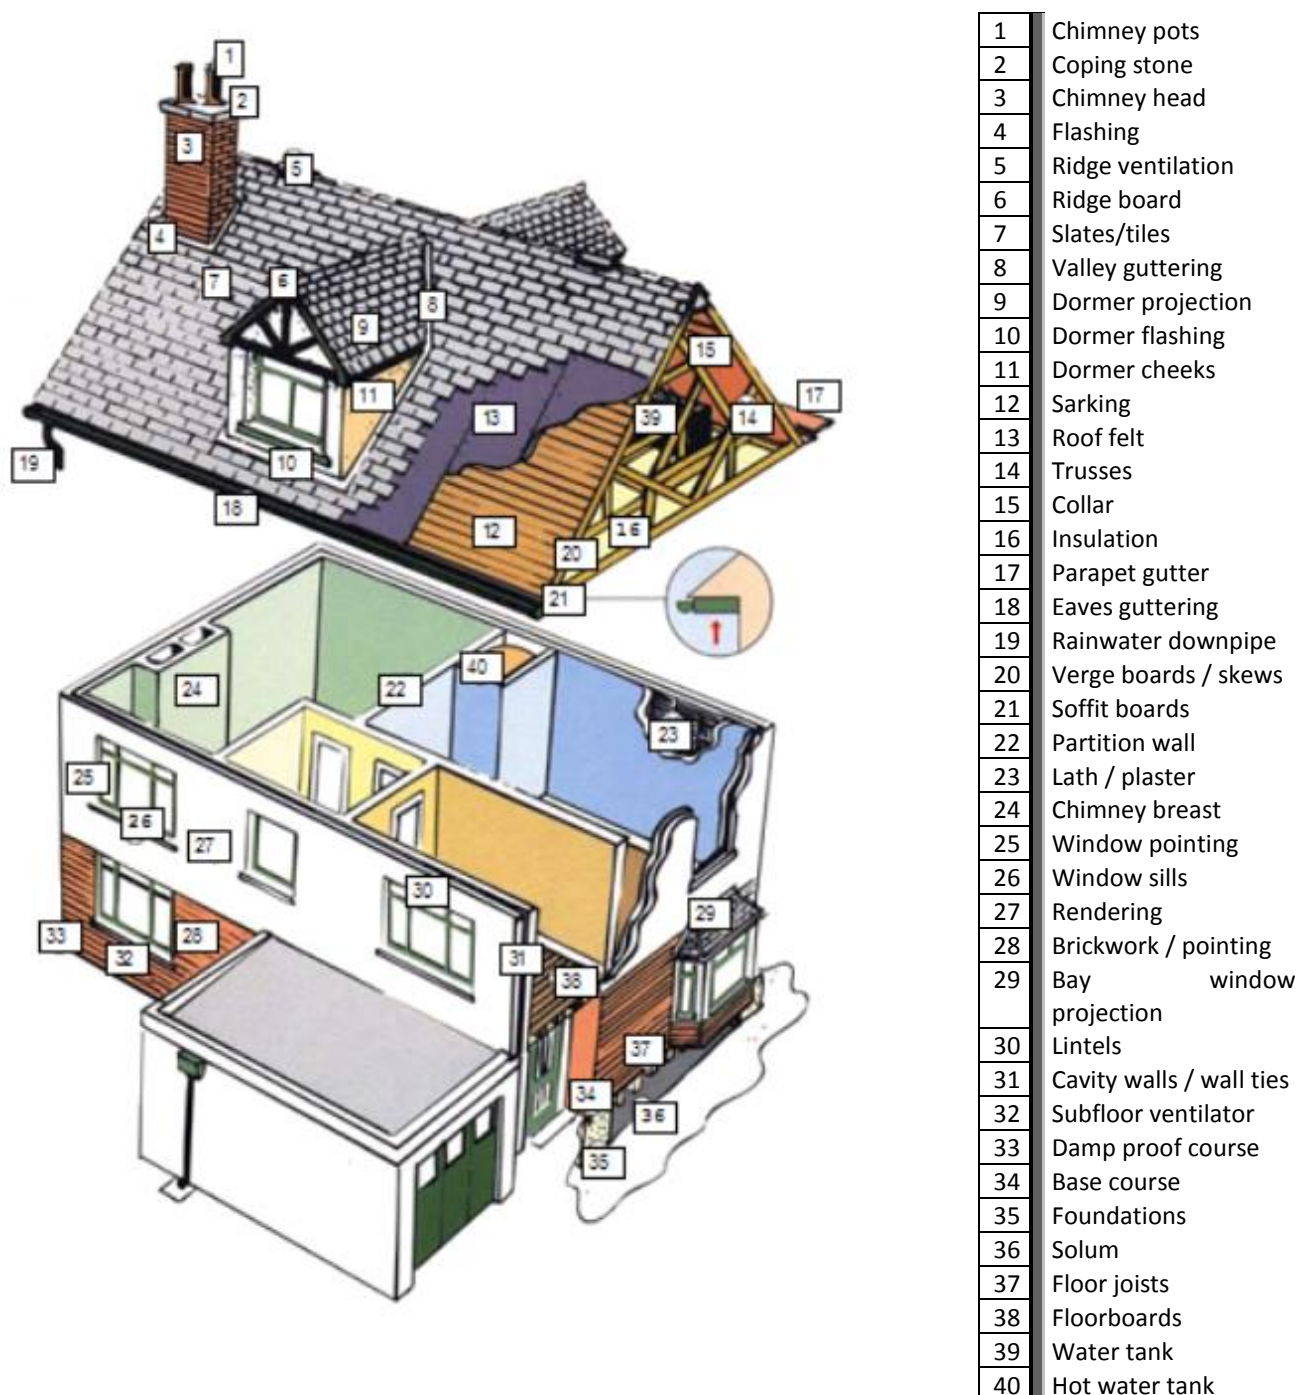
Sectional Diagram showing elements of a typical house

Reference may be made in this report to some or all of the above component parts of the property. This diagram may assist you in locating and understanding these items.

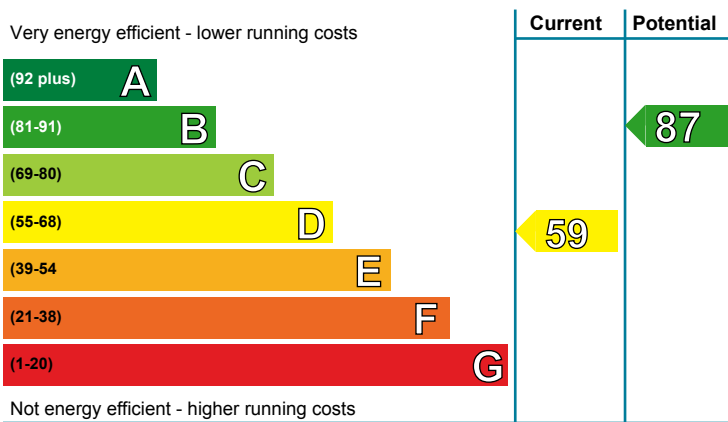
Energy Efficiency Rating

This graph shows the current efficiency of your home, taking into account both energy efficiency and fuel costs. The higher this rating, the lower your fuel bills are likely to be.

Your current rating is **band D (59)**. The average rating for EPCs in Scotland is **band D (61)**.

The potential rating shows the effect of undertaking all of the improvement measures listed within your recommendations report.

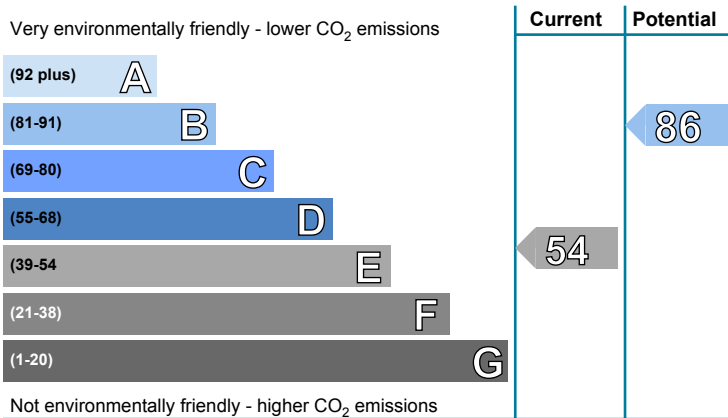
Environmental Impact (CO₂) Rating

This graph shows the effect of your home on the environment in terms of carbon dioxide (CO₂) emissions. The higher the rating, the less impact it has on the environment.
