HOME REPORT

53 Erskine Street, Aberdeen, AB24 3NR

single survey

Property address	53 Erskine Street Aberdeen AB24 3NR
Customer	Ms Holly McArthur
Customer address	c/o Purple Bricks Edinburgh
Date of Inspection	17 th May 2017
Prepared by	David Adamson & Partners Limited Chartered Surveyors 7 Queens Gardens Aberdeen AB15 4YD Tel: +44(0)1224 586 795 Email: valuations@davidadamsongroup.com

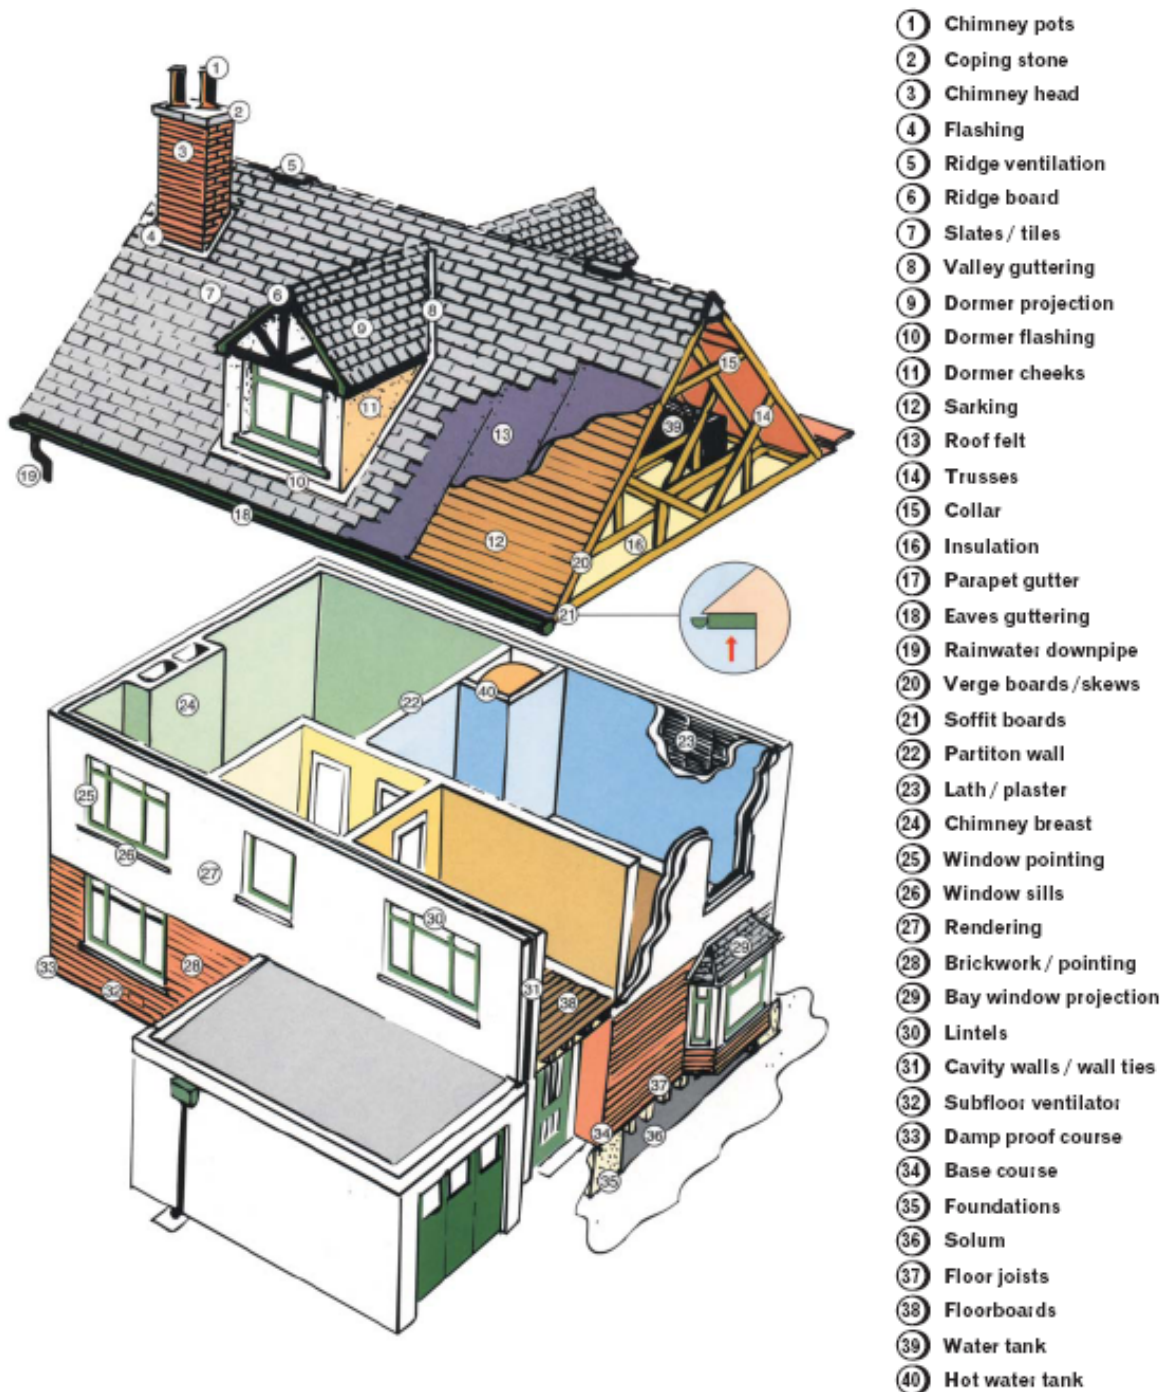
Sectional Diagram showing elements of a typical house

Reference may be made in this report to some or all of the above component parts of the property. This diagram may assist you in locating and understanding these items.

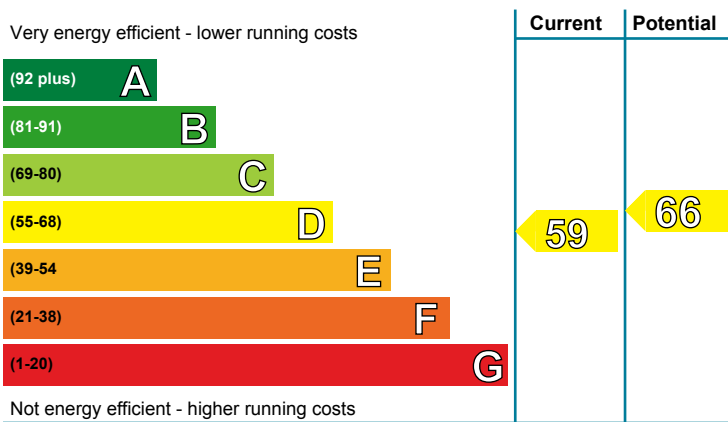
Energy Efficiency Rating

This graph shows the current efficiency of your home, taking into account both energy efficiency and fuel costs. The higher this rating, the lower your fuel bills are likely to be.

Your current rating is **band D (59)**. The average rating for EPCs in Scotland is **band D (61)**.

The potential rating shows the effect of undertaking all of the improvement measures listed within your recommendations report.

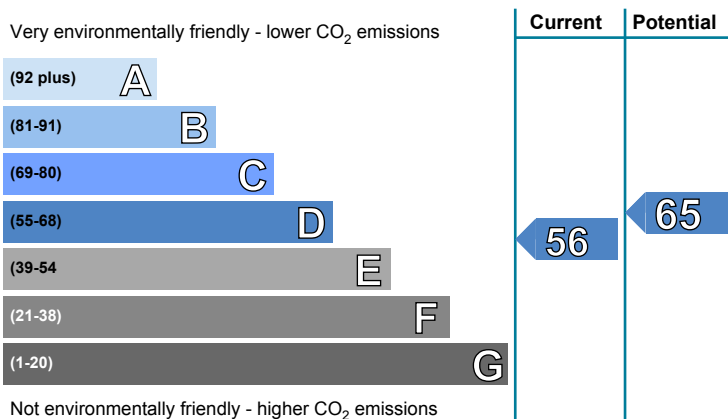
Environmental Impact (CO₂) Rating

This graph shows the effect of your home on the environment in terms of carbon dioxide (CO₂) emissions. The higher the rating, the less impact it has on the environment.
