Single Survey

Property address	65 Catherine Street Aberdeen AB25 1EU
Customer	Miss J Bell
Customer address	Watersedge Fisherwood Road Balloch West Dunbartonshire G83 8SW
Prepared by	ALLIED SURVEYORS SCOTLAND PLC
Date of inspection	28th April 2017

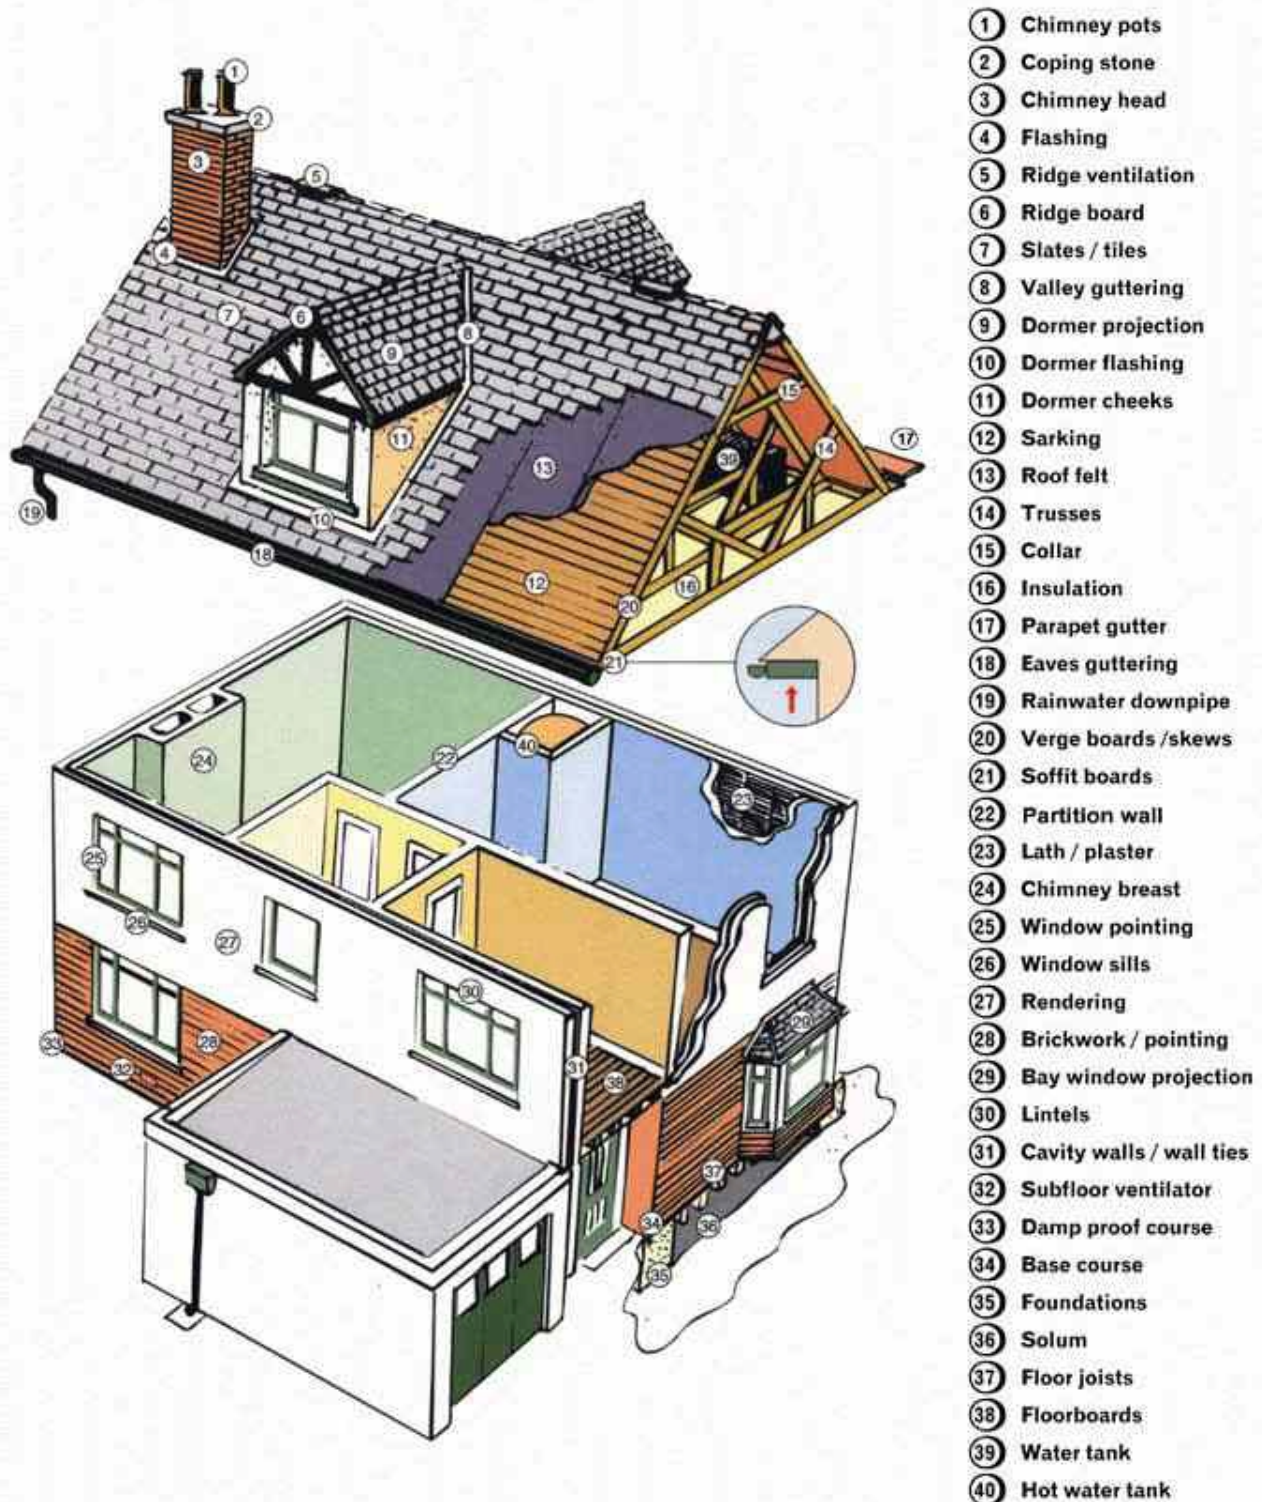
Sectional Diagram showing elements of a typical house

Reference may be made in this report to some or all of the above component parts of the property. This diagram may assist you in locating and understanding these items.
