144b Lochee Road

# Home Report

3/2 , 144B LOCHEE ROAD, DUNDEE, DD2 2LB

# Scottish Single Survey

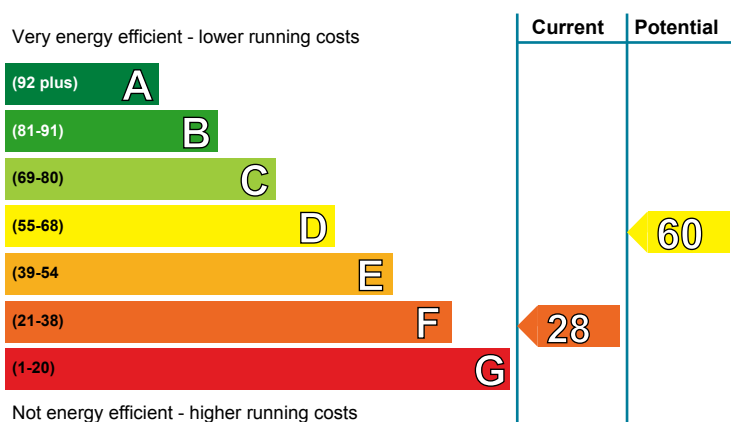
## Energy Efficiency Rating

This graph shows the current efficiency of your home, taking into account both energy efficiency and fuel costs. The higher this rating, the lower your fuel bills are likely to be.

Your current rating is **band F (28)**. The average rating for EPCs in Scotland is **band D (61)**.

The potential rating shows the effect of undertaking all of the improvement measures listed within your recommendations report.

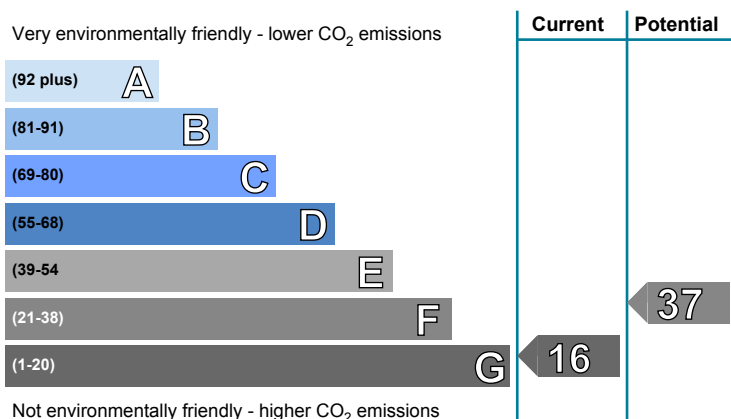
## Environmental Impact (CO<sub>2</sub>) Rating

This graph shows the effect of your home on the environment in terms of carbon dioxide (CO<sub>2</sub>) emissions. The higher the rating, the less impact it has on the environment.

The potential rating shows the effect of undertaking all of the improvement measures listed within your recommendations report.
