YOUR ONESURVEY HOME REPORT

2/2 24 Meadowpark Street Glasgow G31 2RX

SINGLE Survey

A report on the condition of the property, with categories being rated from 1 to 3.

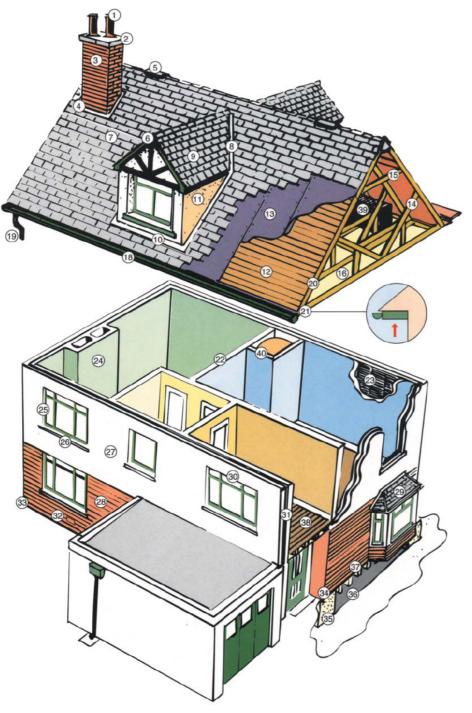
Sectional Diagram showing elements of a typical house

Reference may be made in this report to some or all of the above component parts of the property. This diagram may assist you in locating and understanding these items.

1	Chimney pots
	2	Coping stone
	3	Chimney head
	4	Flashing
	5	Ridge ventilation
	6	Ridge board
	1	Slates / tiles
	8	Valley guttering
	9	Dormer projection
	10	Dormer flashing
	11	Dormer cheeks
	12	Sarking
•	13	Roof felt
	14	Trusses
	15	Collar
	16	Insulation
	17	Parapet gutter
	18	Eaves guttering
	19	Rainwater downpipe
	20	Verge boards/skews
	21	Soffit boards
	22	Partiton wall
	23	Lath / plaster
	24	Chimney breast
	25	Window pointing
	26	Window sills
	27	Rendering
	28	Brickwork / pointing
	29	Bay window projection
	30	Lintels
	31	$\ensuremath{\textbf{C}}\xspace$ avity walls / wall ties
	32	Subfloor ventilator
	33	Damp proof course
	34	Base course
	35	Foundations
	36	Solum
	37	Floor joists
	38	Floorboards
	39	Water tank
	40	Hot water tank
