SINGLE SURVEY REPORT

**37 BOSWALL AVENUE
EDINBURGH
EH5 2EA**

Date of inspection: 16 MAY 2017

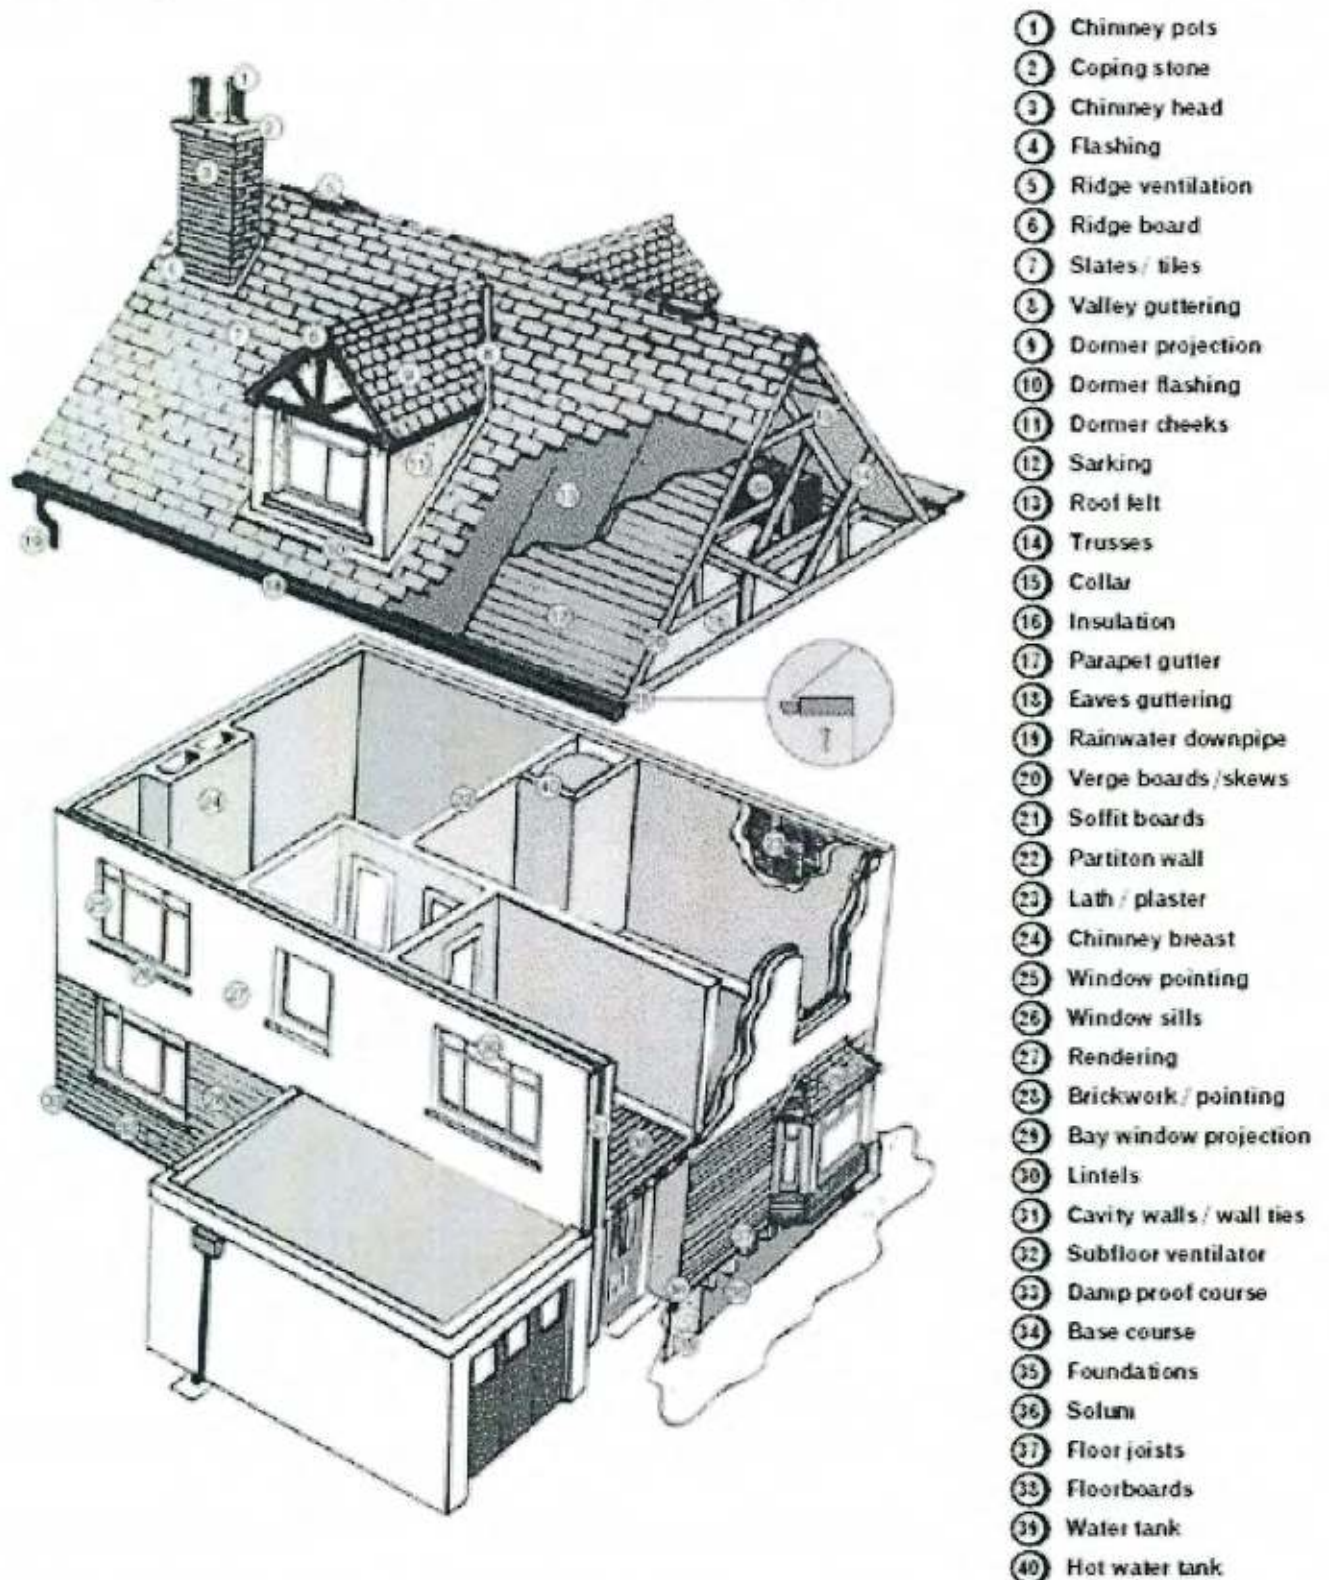
Sectional diagram showing elements of a typical house

Reference may be made in this report to some or all of the above component parts of the property. This diagram may assist you in locating and understanding these terms.

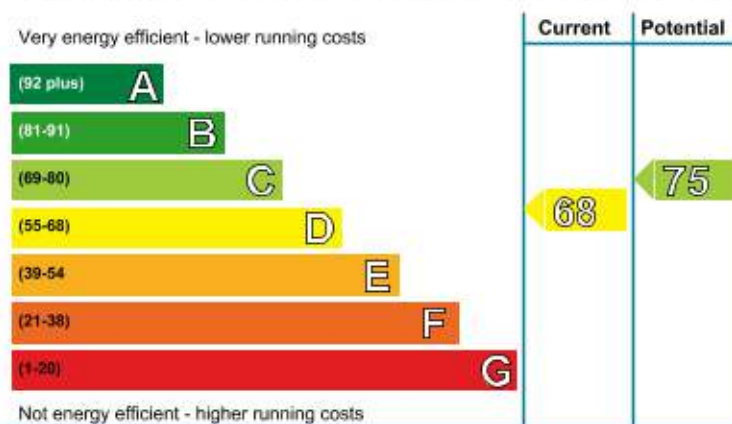
Energy Efficiency Rating

This graph shows the current efficiency of your home, taking into account both energy efficiency and fuel costs. The higher this rating, the lower your fuel bills are likely to be.

Your current rating is **band D (68)**. The average rating for EPCs in Scotland is **band D (61)**.

The potential rating shows the effect of undertaking all of the improvement measures listed within your recommendations report.

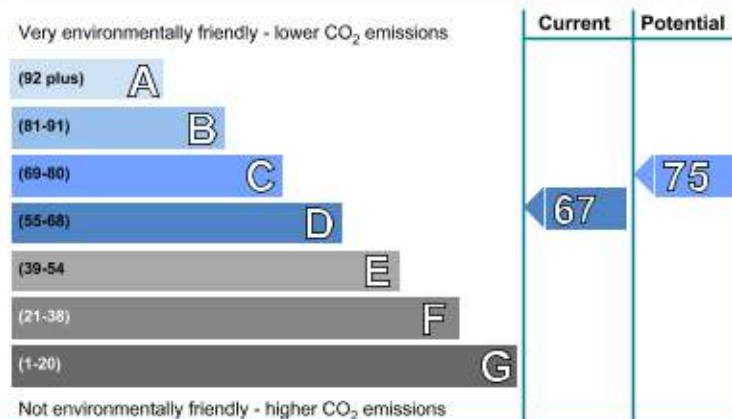
Environmental Impact (CO₂) Rating

This graph shows the effect of your home on the environment in terms of carbon dioxide (CO₂) emissions. The higher the rating, the less impact it has on the environment.
