White Gates Heather Drive

# Home Report

White Gates, Heather Drive, Blairgowrie, PH10 6LN

# Scottish Single Survey

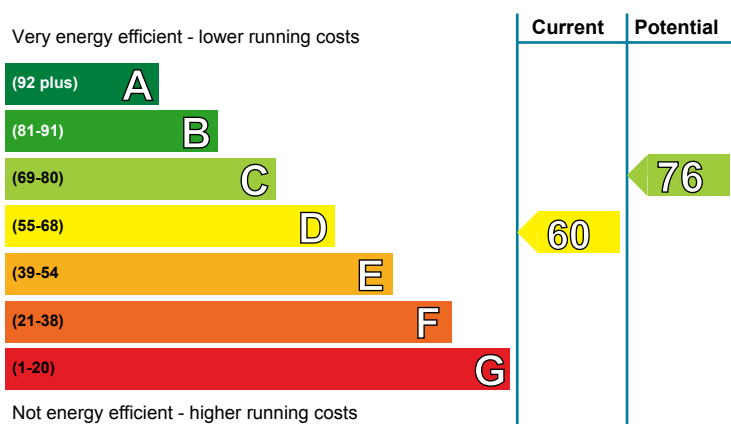
## Energy Efficiency Rating

This graph shows the current efficiency of your home, taking into account both energy efficiency and fuel costs. The higher this rating, the lower your fuel bills are likely to be.

Your current rating is **band D (60)**. The average rating for EPCs in Scotland is **band D (61)**.

The potential rating shows the effect of undertaking all of the improvement measures listed within your recommendations report.
