10 BONFIELD ROAD  
STRATHKINNESS  
ST ANDREWS  
KY16 9RP

# Home Report

**Dwelling type:** Detached house  
**Date of assessment:** 06 June 2017  
**Date of certificate:** 16 June 2017  
**Total floor area:** 226 m<sup>2</sup>  
**Primary Energy Indicator:** 313 kWh/m<sup>2</sup>/year

# Scottish Single Survey

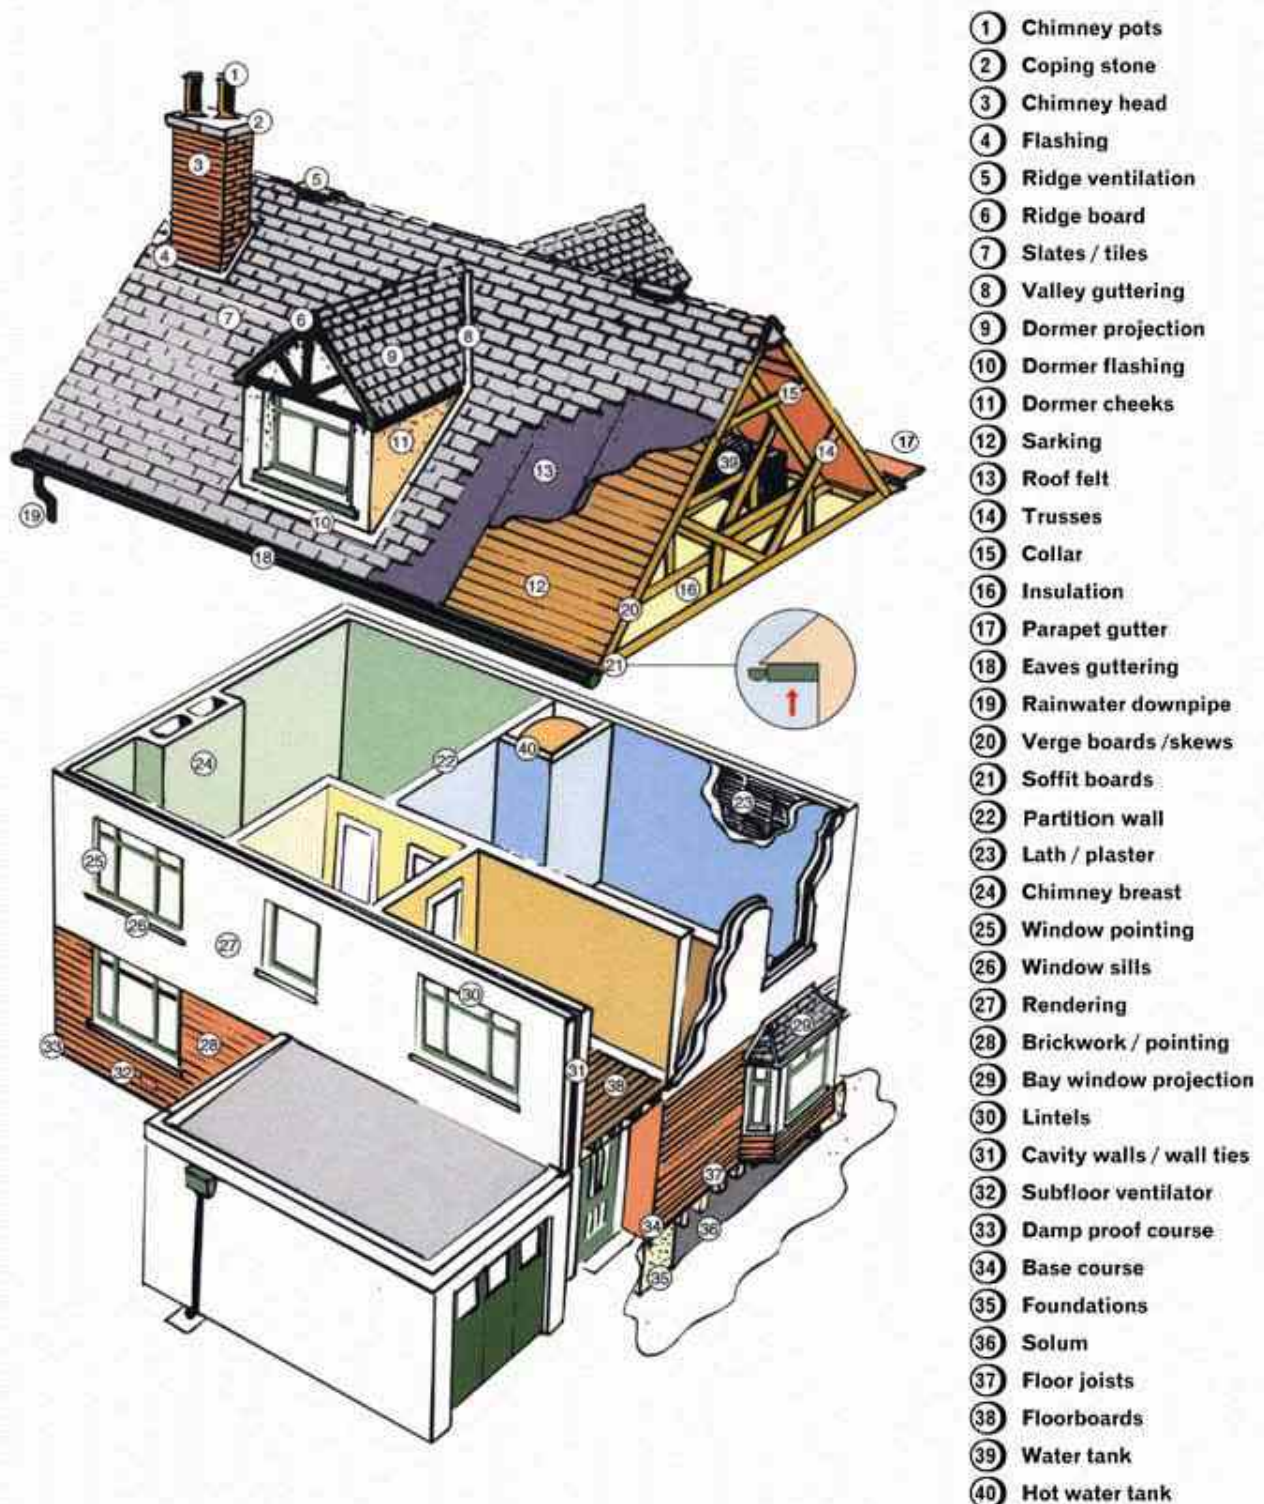
## Sectional Diagram showing elements of a typical house

Reference may be made in this report to some or all of the above component parts of the property. This diagram may assist you in locating and understanding these items.
