## SINGLE SURVEY REPORT

12 CRAIGMOUNT VIEW EDINBURGH EH12 8BT

Date of inspection:

4 JULY 2017

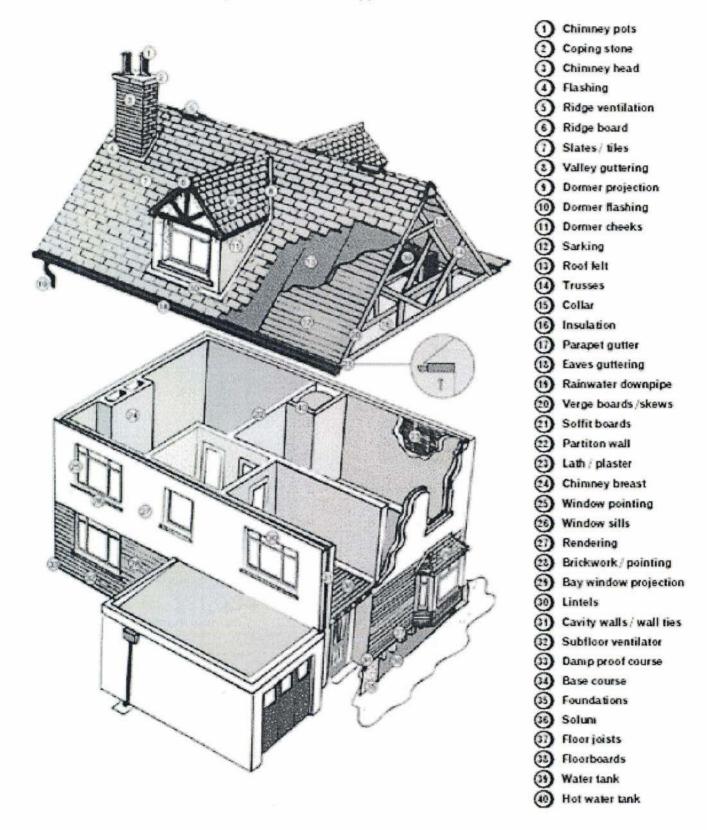
## Sectional diagram showing elements of a typical house

Reference may be made in this report to some or all of the above component parts of the property. This diagram may assist you in locating and understanding these terms.
