**SHEPHERD**  
**HOME REPORT**

59 STATION ROAD  
THORNTON  
KIRKCALDY  
KY1 4AY

# Energy Performance Certificate (EPC)

59 STATION ROAD, THORNTON, KIRKCALDY, KY1 4AY

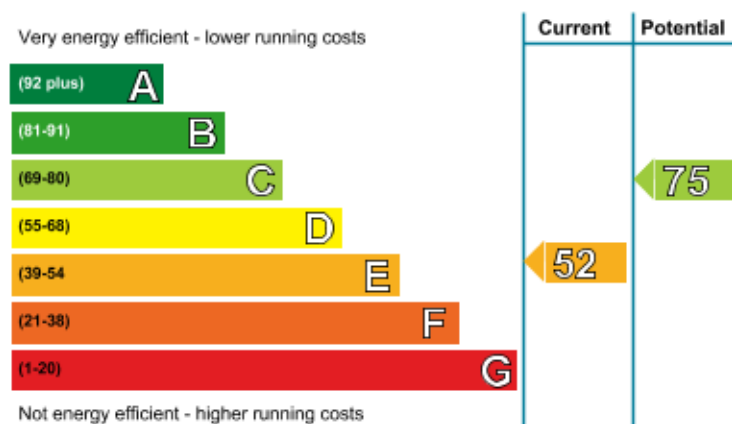
## Energy Efficiency Rating

This graph shows the current efficiency of your home, taking into account both energy efficiency and fuel costs. The higher this rating, the lower your fuel bills are likely to be.

Your current rating is **band E (52)**. The average rating for EPCs in Scotland is **band D (61)**.

The potential rating shows the effect of undertaking all of the improvement measures listed within your recommendations report.
