**Shepherd Chartered Surveyors**

54b Scott Street  
Perth  
PH2 8JW

# Energy Performance Certificate (EPC)

# Scottish Single Survey

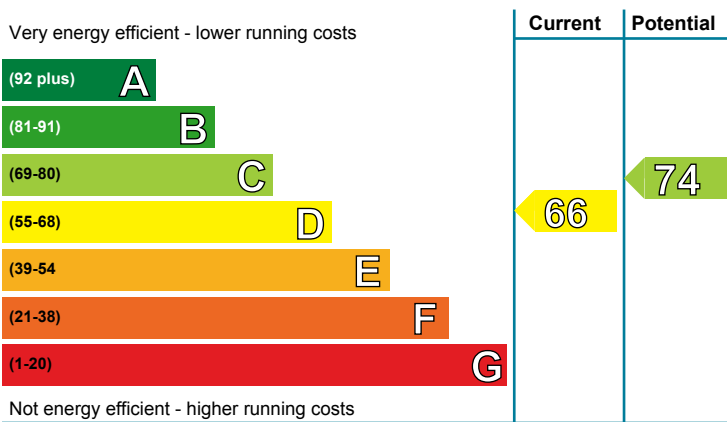
## Energy Efficiency Rating

This graph shows the current efficiency of your home, taking into account both energy efficiency and fuel costs. The higher this rating, the lower your fuel bills are likely to be.

Your current rating is **band D (66)**. The average rating for EPCs in Scotland is **band D (61)**.

The potential rating shows the effect of undertaking all of the improvement measures listed within your recommendations report.

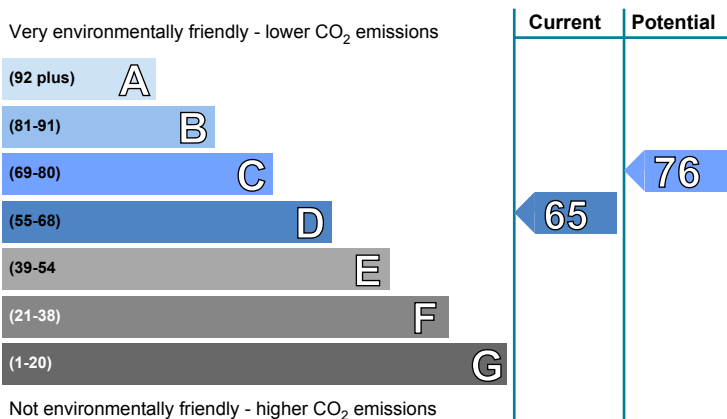
## Environmental Impact (CO<sub>2</sub>) Rating

This graph shows the effect of your home on the environment in terms of carbon dioxide (CO<sub>2</sub>) emissions. The higher the rating, the less impact it has on the environment.

Your current rating is **band D (65)**. The average rating for EPCs in Scotland is **band D (59)**.

The potential rating shows the effect of undertaking all of the improvement measures listed within your recommendations report.
